MECKLENBURG COUNTY
DEPARTMENT OF ENVIRONMENTAL HEALTH

APPLICATION FOR SOIL INVESTIGATION

MECKLENBURG COUNTY ENVIRONMENTAL HEALTH
SITE EVALUATION REPORT
SERIAL NUMBER 10050

MECKLENBURG COUNTY ENVIRONMENTAL HEALTH File: 20133 Action 3
SITE EVALUATION REPORT
SERIAL NUMBER 11855 Parcel: 111-311-34 PC

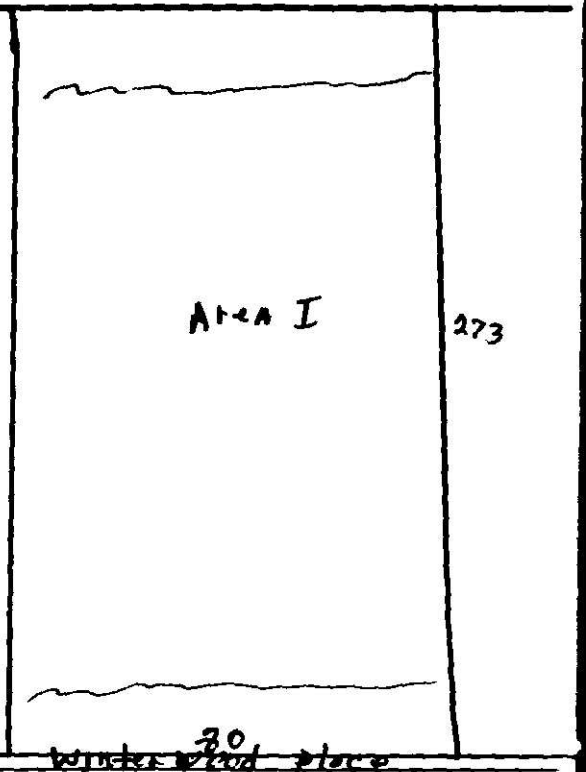
At your request a soils investigation was conducted on the property designated above. Results of this investigation showed the site to be classified as UNSUITABLE under criteria as set forth in Section .1900 of the North Carolina Administrative Code, Title 10, Department of Human Resources, Chapter 10, Division of Health Services; Sanitary Engineering Section, Subchapter 10A, Sanitation. A copy of the site evaluation report (Serial No. 10050) is enclosed for your information.

The soil on this property is not suitable for use with any conventional system, modified or alternative, with which I am aware.

*** EVALUATION KEY ***
S = Suitable U = Unsuitable
PS = Provisionally Suitable
The "Area Classification" below indicates the suitability of areas in the diagram.

FACTORS	AREA 1	AREA 2	AREA 3	AREA 4	AREA 5	AREA 6
Topography	S (PS) U 1-2	S PS U	S PS U	S PS U	S PS U	S PS U
Texture	S PS (U)	S PS U	S PS U	S PS U	S PS U	S PS U
Structure	S PS (U)	S PS U	S PS U	S PS U	S PS U	S PS L
Drainage	S PS (U) 10 – 15 H20	S PS U	S PS U	S PS U	S PS U	S PS L
Depth	S PS (U) 20"	S PS U	S PS U	S PS U	S PS U	S PS L
Restrictive Horizons	S (PS) U	S PS U	S PS U	S PS U	S PS U	S PS L
Available Space	S (PS) U	S PS U	S PS U	S PS U	S PS U	S PS L
Other (specify)	S PS U	S PS U	S PS U	S PS U	S PS U	S PS L
Soil Group/Series	Helena					
Area Classification	S PS (U)	S PS U	S PS U	S PS U	S PS U	S PS L
