APPLICATION FOR PERCOLATION TEST

SOIL INVESTIGATION REPORT

Location of Property Little Creek Rd. lot No. 7 Block B

SITE INVESTIGATION REPORT
INDIVIDUAL SEPTIC TANK SYSTEM
WITH SUBSURFACE,
SOIL ABSORPTION,
EFFLUENT DISCHARGE

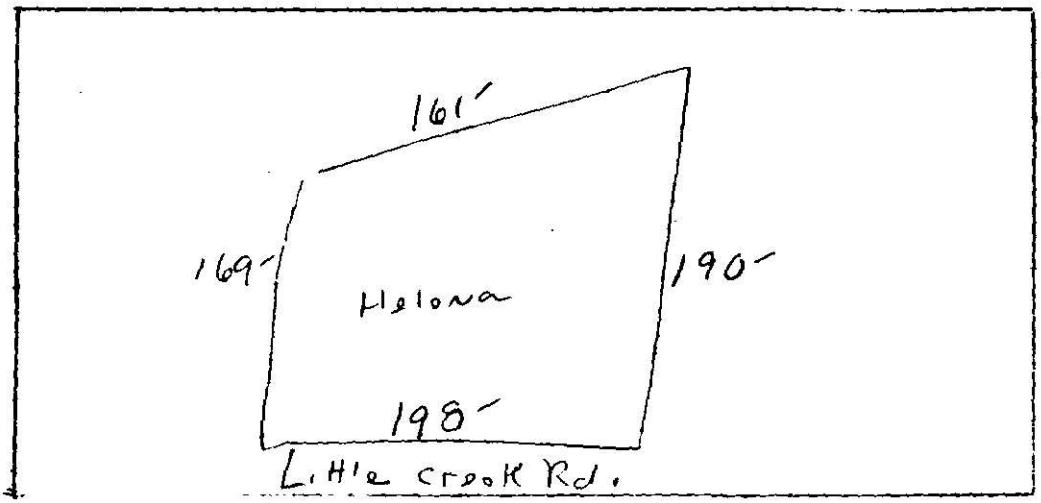
DIAGRAM OF PROPERTY

Soil Properties	Soil 1	Soil 2	Soil 3	Soil 4
1. Soil Series	Holona			
2. Soil Slope	unsuitable 2-6%			
3. Soil Depth	unsuitable <30"			
4. Soil Texture	unsuitable 2:1 Expanding Clay			
5. Soil Structure	unsuitable Massive			
6. Restrictive Horizons	—			
7. Soil Drainage	unsuitable perched high water table			
8. Soil Permeability (Percolation Rate)	unsuitable very slow >60 min/inch			
9. Other	—			
10. Overall Rating	unsuitable

Recommendations Based on this investigation, the lot was found to have soils dominantly unsuitable for installation of a septic tank system.

Lot rechecked 12-7-78. no change in suitability of lot. William A. Martin Soil Scientist
