APPLICATION FOR PERCOLATION TEST

SOIL INVESTIGATION REPORT

SITE INVESTIGATION REPORT
INDIVIDUAL SEPTIC TANK SYSTEM
WITH SUBSURFACE,
SOIL ABSORPTION,
EFFLUENT DISCHARGE

LOCATION OF LOT Lindsay Lane, Lot 7 & 8, Block 1

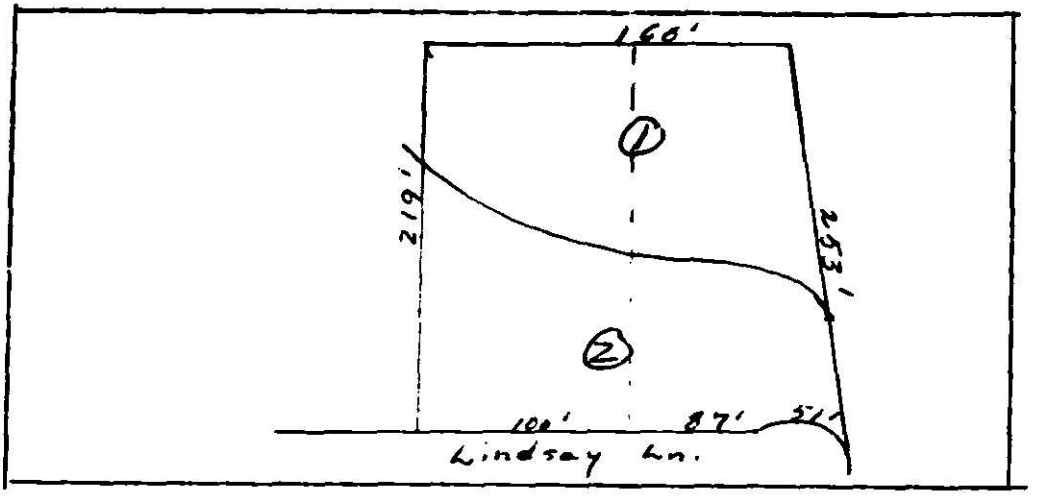
DIAGRAM OF PROPERTY

Soil Properties	Soil 1	Soil 2	Soil 3	Soil 4
1. Soil Series	Wilkes	Enon		
2. Soil Slope	Acceptable 2-8%	Acceptable 2-4%		
3. Soil Depth	Unacceptable <20"	Unacceptable <36"		
4. Soil Texture	Unacceptable silt clay	Unacceptable silt clay		
5. Soil Structure	Unacceptable massive	Unacceptable massive		
6. Restrictive Horizons	—	—		
7. Soil Drainage	Acceptable W.T. >48"	Acceptable W.T. >48"		
8. Soil Permeability (Percolation Rate)	Unacceptable >120 min/in	Unacceptable >120 min/in		
9. Other	—	—		
10. Overall Rating	Unacceptable	Unacceptable

Recommendations Lot not recommended for installation of a septic tank system

Unsuitable soil

Slow Permeability and percolation rate
