MECKLENBURG COUNTY HEALTH DEPARTMENT

APPLICATION FOR PERCOLATION TEST

SOIL INVESTIGATION REPORT

SITE INVESTIGATION REPORT
INDIVIDUAL SEPTIC TANK SYSTEM
WITH SUBSURFACE,
SOIL ABSORPTION,
EFFLUENT DISCHARGE

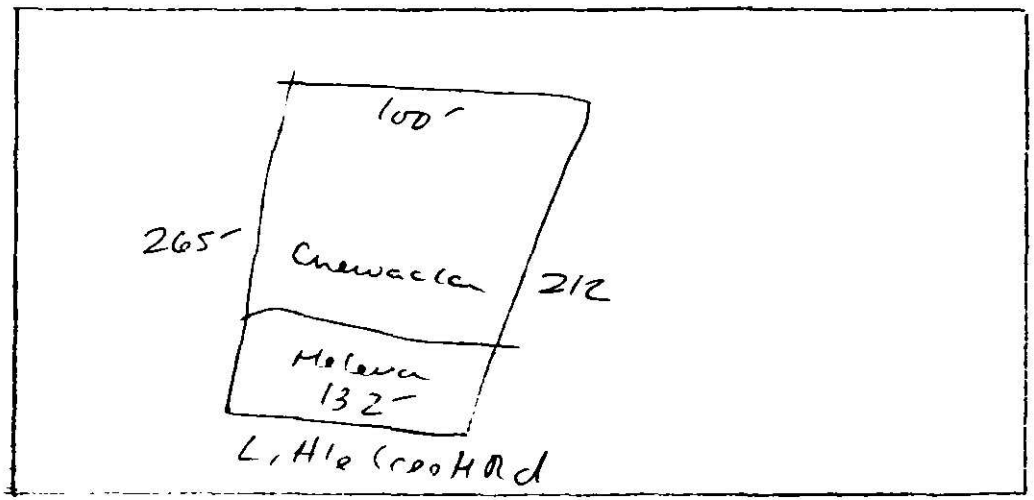
DIAGRAM OF PROPERTY

Soil Properties	Soil 1	Soil 2	Soil 3	Soil 4
1. Soil Series	Helena		Chewacla	
2. Soil Slope	suitable 2-6%		—	
3. Soil Depth	unsuitable <48"		—	
4. Soil Texture	unsuitable 2:1 clays		—	
5. Soil Structure	unsuitable massive		—	
6. Restrictive Horizons	—		—	
7. Soil Drainage	unsuitable perched high water table		unsuitable poorly drained	
8. Soil Permeability (Percolation Rate)	unsuitable very slow		unsuitable seasonal	water table ≤18"
9. Other	>200 min/in.		unsuitable floods	from surface
10. Overall Rating	unsuitable		unsuitable

Recommendations Based on this investigation, the lot was found to have soils dominantly unsuitable for installation of a septic tank system.
