APPLICATION FOR PERCOLATION TEST

SITE EVALUATION

SITE INVESTIGATION REPORT
INDIVIDUAL SEPTIC TANK SYSTEM
WITH SUBSURFACE,
SOIL ABSORPTION,
EFFLUENT DISCHARGE

LOCATION OF LOT Timber Ridge Drive, Lot 19, Block J

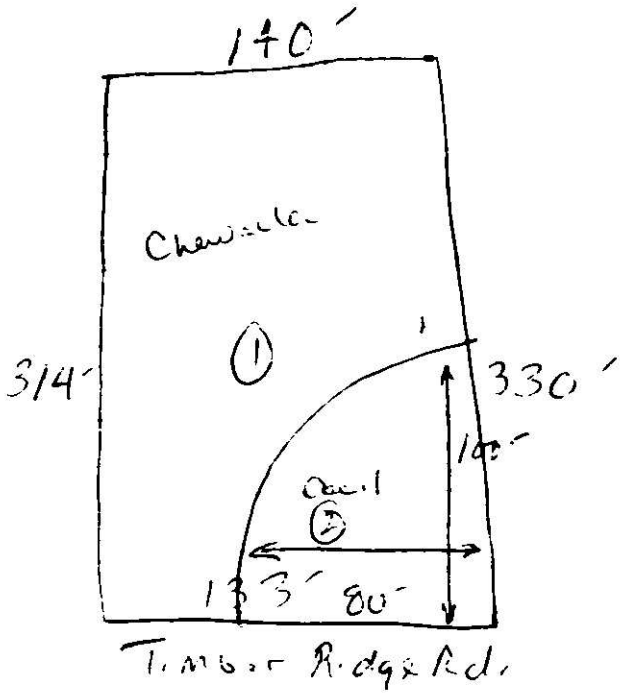
FACTORS	AREA 1	AREA 2	AREA 3	AREA 4
1. SLOPE (%)	S PS U	S PS 4-12% U	S PS U	S PS U
2. SOIL TEXTURE (12-36 in.) (Sandy, loamy, clayey, Not. .:l clay)	S PS U	S PS clay U	S PS U	S PS U
3. SOIL STRUCTURE (12-36 in.) (Clayey soils)	S PS U	S PS blocky U	S PS U	S PS U
4. SOIL DEPTH (In.)	S PS U	S PS >48" U	S PS U	S PS U
5. RESTRICTIVE HORIZONS (In.) (Impervious Strata, rock)	S PS U	S PS U	S PS U	S PS U
6. SOIL DRAINAGE/GROUNDWATER (External & Internal)	S PS U Poorly	S PS U Poor	S PS U	S PS U
7. SOIL PERMEABILITY (Percolation Rate)	S PS U	S PS Moderate U	S PS U	S PS U
8. OTHER (Specify)	S PS U Soils	S PS U	S PS U	S PS U
9. SITE CLASSIFICATION*				
SOIL SERIES	Chewacla	Cecil

Recommendations/Comments: Based on this investigation the lot does not appear to have an adequate area of provisionally suitable soils for installation of a septic tank system

140'
Chevalier
1
314'
330'
140'
Oac. 1
2
133'
80'
Timber Ridge Rd.
