APPLICATION FOR SOIL INVESTIGATION

APPENDIX H
SITE EVALUATION

SITE INVESTIGATION REPORT
INDIVIDUAL SEPTIC TANK SYSTEM
WITH SUBSURFACE,
SOIL ABSORPTION,
EFFLUENT DISCHARGE

LOCATION OF LOT Brickstone Drive Sunset Hills Subdivision Lots 76 and 77

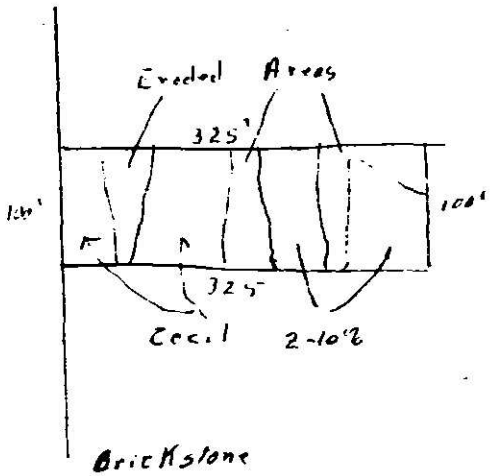
FACTORS	AREA 1	AREA 2	AREA 3	AREA 4
1. SLOPE (%)	(S) 2-10% PS U	S complex PS slopes (U)	S PS U	S PS U +
2. SOIL TEXTURE (12-36 in.) (Sandy, loamy, clayey, Note 2:1, Clay)	S (PS) Clay U	S (PS) clay U	S PS U	S PS U
3. SOIL STRUCTURE (12.36 in.) (Clayey Soils)	S (PS) Blocky U	S (PS) Blocky U	S PS U	S PS U
4. SOIL DEPTH (In.)	(S) 48" PS U	S Depth PS Variable (U)	S PS U	S PS U
5. RESTRICTIVE HORIZONS (In.) (Impervious Strata, Rock)	(S) None PS U	(S) None PS U	S PS U	S PS U
6. SOIL DRAINAGE/GROUNDWATER (External & Internal)	(S) 76" ground water PS U	S Eroded Areas PS Channel (U) water	S PS U	S PS U
7. SOIL PERMEABILITY (Percolation Rate)	S (PS) Moderate U	S (PS) Moderate U	S PS U	S PS U
8. OTHER (Specify)	S Very Critical PS Area (U)	S PS U	S PS U	S PS U
9. SITE CLASSIFICATION	unsuitable	unsuitable		
SOIL SERIES	Cecil	Eroded Areas

Eroded Areas
325'
100'
100'
325'
Cecil
2-10%
Brick stone
