MECKLENBURG COUNTY
DEPARTMENT OF ENVIRONMENTAL HEALTH

APPLICATION FOR SOIL INVESTIGATION

APPENDIX
SITE EVALUATION

SITE INVESTIGATION REPORT
INDIVIDUAL SEPTIC TANK SYSTEM
WITH SUBSURFACE,
SOIL ABSORPTION,
EFFLUENT DISCHARGE

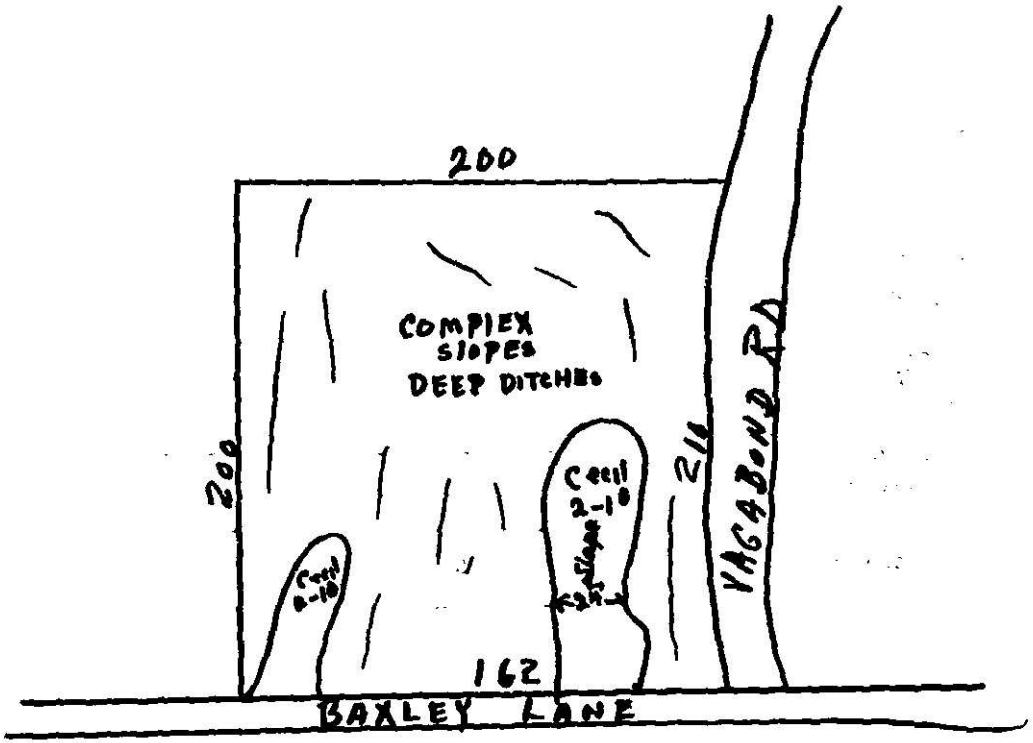
FACTORS	AREA 1	AREA 2	AREA 3	AREA 4
1. SLOPE (%)	S (PS) U — Level	S PS (U) — Complex Slopes	S PS U	S PS U
2. SOIL TEXTURE (12-36 inches) Sandy, Loamy, Clayey (Note 2:1 Clay)	S (PS) U — Clayey	S PS (U) — Clayey To Saprolite	S PS U	S PS U
3. SOIL STRUCTURE (12-36 inches)	S (PS) U — Blocky	S PS (U) — Blocky To Massive	S PS U	S PS U
4. SOIL DEPTH (inches)	S (PS) U — 48	S PS (U) — <48	S PS U	S PS U
5. RESTRICTIVE HORIZONS (inches) (Impervious strata, Rock)	S (PS) U — NONE	S PS (U) — Saprolite	S PS U	S PS U
6. SOIL DRAINAGE/GROUNDWATER (external and internal)	S (PS) U — Adequate	S PS (U) — Slow	S PS U	S PS U
7. SOIL PERMEABILITY (percolation rate)	S (PS) U — Moderate	S PS (U) — Slow	S PS U	S PS U
8. OTHER (specify)	S PS U	S PS U	S PS U	S PS U
9. SITE CLASSIFICATION	P. Suitable	Unsuitable		
10. SOIL SERIES	Cecil	Eroded Cecil (Deep Dilolas)

Recommendations/Comments: Small Area of Uneroded Cecil May Not Be Useable Due To Slope + Position on The Lot.

Limited area of provisionally suitable soils.

Please submit plot plans of proposed location of residence and septic tank system.
