MECKLENBURG COUNTY
DEPARTMENT OF ENVIRONMENTAL HEALTH

APPLICATION FOR SOIL INVESTIGATION

APPENDIX H
SITE EVALUATION
(Ground Absorption Sewage Disposal)

SITE INVESTIGATION REPORT
INDIVIDUAL SEPTIC TANK SYSTEM
WITH SUBSURFACE,
SOIL ABSORPTION,
EFFLUENT DISCHARGE

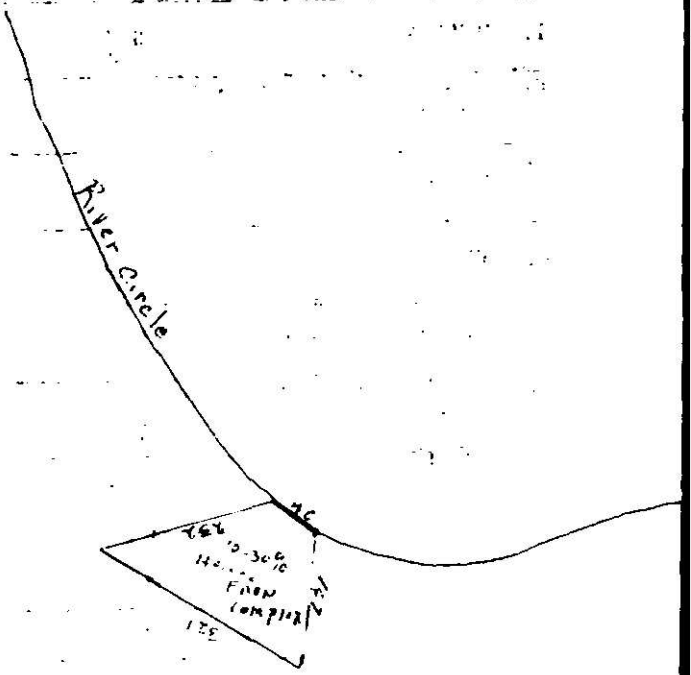
FACTORS	AREA 1	AREA 2	AREA 3	AREA 4
1. SLOPE (%)	S PS 10-30 (U)	S PS U	S PS U	S PS U
2. SOIL TEXTURE (12-36 in.) (Sandy, loamy, clayey, Note 2:1, Clay)	S PS 2-1 clay (U)	S PS U	S PS U	S PS U
3. SOIL STRUCTURE (12-36 in.) (Clayey Soils) ✓	S PS Massive (U)	S PS U	S PS U	S PS U
4. SOIL DEPTH (In.)	S PS <48" (U)	S PS U	S PS U	S PS U
5. RESTRICTIVE HORIZONS (In.) (Impervious Strata, Rock)	S Rock + clay PS <48" (U)	S PS U	S PS U	S PS U
6. SOIL DRAINAGE/GROUNDWATER (External & Internal)	S PS slow (U)	S PS U	S PS U	S PS U
7. SOIL PERMEABILITY (Percolation Rate) ✓	S PS slow (U)	S PS U	S PS U	S PS U
8. OTHER (Specify)	S PS U	S PS U	S PS U	S PS U
9. SITE CLASSIFICATION ✓	Unsuitable			
SOIL SERIES	Helena Enon complex

Soil Structure Massive
Soil Permeability Unsuitable
Site Classification Unsuitable
