APPLICATION FOR SOIL INVESTIGATION

SOIL INVESTIGATION REPORT

SITE INVESTIGATION REPORT
INDIVIDUAL SEPTIC TANK SYSTEM
WITH SUBSURFACE,
SOIL ABSORPTION,
EFFLUENT DISCHARGE

LOCATION OF LOT Marlwood CircleLot 19, Block B

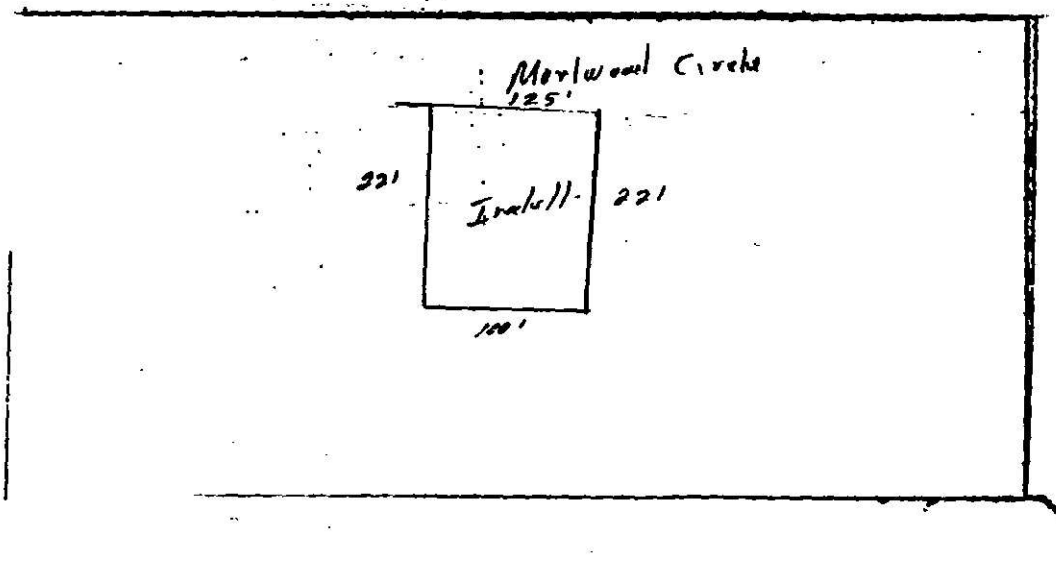
DIAGRAM OF PROPERTY

Soil Properties	Soil 1	Soil 2	Soil 3	Soil 4
1. Soil Series	Tonkoll			
2. Soil Slope	Suitable 2-6%			
3. Soil Depth	unsuitable L36"			
4. Soil Texture	unsuitable 2-1 Expanding Clay			
5. Soil Structure	unsuitable Massive			
6. Restrictive Horizons	-			
7. Soil Drainage	Unsuitable Perched High water Table			
8. Soil Permeability (Percolation Rate)	unsuitable slow 720 min/in			
9. Other				
10. Overall Rating	unsuitable

Remarks
Recommendations Based on this investigation, the soil on the lot was found to be unsuitable for installation of a septic tank system.
