MECKLENBURG COUNTY
DEPARTMENT OF ENVIRONMENTAL HEALTH

APPLICATION FOR SOIL INVESTIGATION

SOIL INVESTIGATION REPORT

SOIL INVESTIGATION REPORT
INDIVIDUAL SEPTIC TANK SYSTEM
WITH SUBSURFACE,
SOIL ABSORPTION,
EFFLUENT DISCHARGE

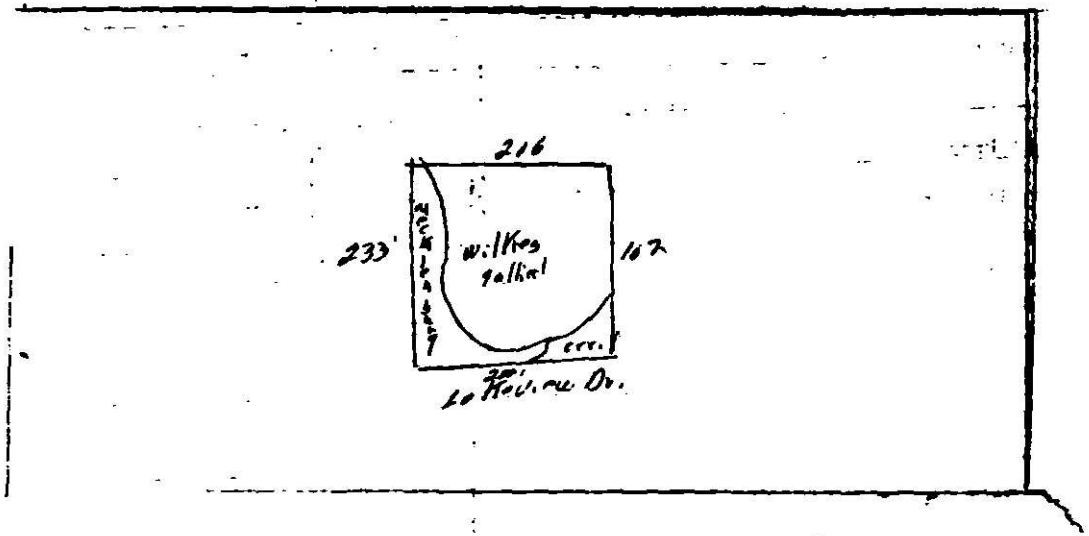
DIAGRAM OF PROPERTY

Soil Properties	Soil 1	Soil 2	Soil 3	Soil 4
1. Soil Series	Wilkes gullied	Mecklenburg	Cecil	
2. Soil Slope	unsuitable complex 36pos	Suitable 6-12%	Suitable 10-15%	
3. Soil Depth	unsuitable ± 20"	suitable 45"	Suitable 7+0"	
4. Soil Texture	unsuitable 2-1 E mond. Clay	unsuitable 2-1 E mond. Clay	Provisionally suitable Clay	
5. Soil Structure	unsuitable Massive	unsuitable Massive	Provisionally suitable Blocky	
6. Restrictive Horizons				
7. Soil Drainage	unsuitable Potential lateral water Movement	Suitable water Table 70'	Suitable water Table 76'	
8. Soil Permeability (Percolation Rate)	unsuitable slow 72:00 min/in	unsuitable slow 72:00 min/in	Provisionally suitable Moderate 60 Min/in	
9. Other			Inadequate if Acceptable	Area Soil
10. Overall Rating	unsuitable	unsuitable	unsuitable

Recommendations Removed. Based on this investigation, ~~there~~ there is not an adequate area of provisionally suitable soil on the lot for the installation of a septic tank system.
