APPLICATION FOR SOIL INVESTIGATION

APPENDIX II
SITE EVALUATION

SITE INVESTIGATION REPORT
INDIVIDUAL SEPTIC TANK SYSTEM
WITH SUBSURFACE,
SOIL ABSORPTION,
EFFLUENT DISCHARGE

S.I.R. # 15797

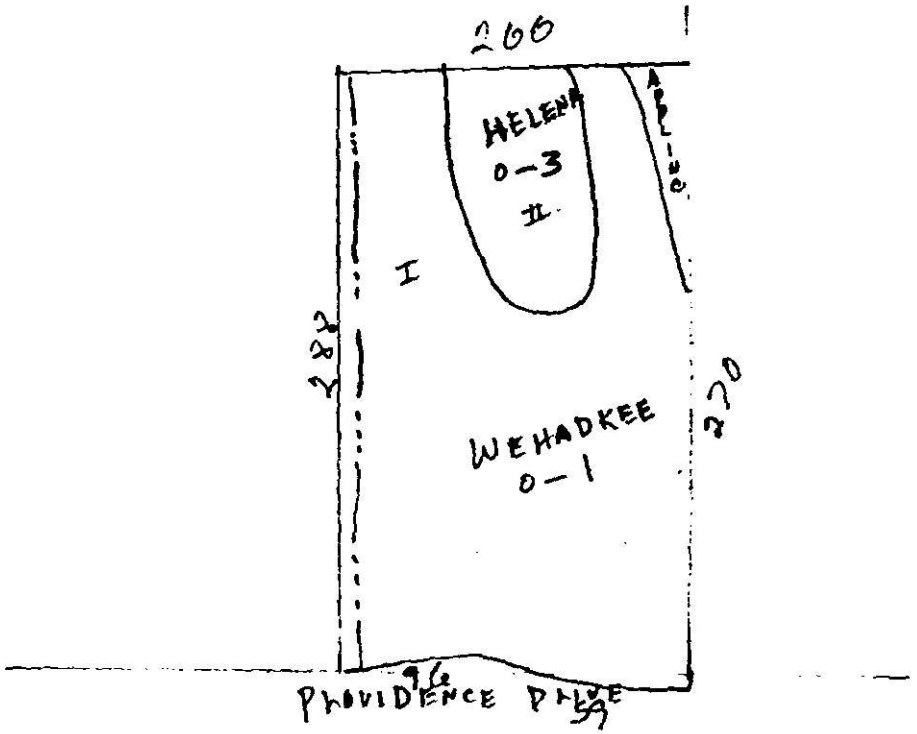
FACTORS	AREA 1	AREA 2	AREA 3	AREA 4
1. SLOPE (%)	S (PS) U — 0-1	S (PS) U — 0-3	S PS U	S PS U
2. SOIL TEXTURE (12-36 in.) (Sandy, loamy, clayey, Note 2:1 Clay)	S (PS) U — Sandy Loam	S PS (U) — Clayey Mixed	S PS U	S PS U
3. SOIL STRUCTURE (12-36 in.) (Clayey Soils)	S (PS) U — Granular To Blocky	S PS U — Blocky To Massive	S PS U	S PS U
4. SOIL DEPTH (In.)	S PS (U) — 48	S PS (U) — 48	S PS U	S PS U
5. RESTRICTIVE HORIZONS (In.) (Impervious Strata, Rock)	S PS (U) — Hardpan	S PS (U) — Clay	S PS U	S PS U
6. SOIL DRAINAGE/GROUNDWATER (External & internal)	S PS (U) — Flooded	S PS (U) — Very High water Table	S PS U	S PS U
7. SOIL PERMEABILITY (Percolation Rate)	S (PS) U — Moderate	S PS (U) — Slow	S PS U	S PS U
8. OTHER (Specify)	S PS U	S PS U	S PS U	S PS U
9. SITE CLASSIFICATION	✓ Unsuitable (SWAMP)	Unsuitable		
SOIL SERIES	WEHADKEE	HELENA

200
HELENA
0-3
II
I
APPLING
282
270
WEHADKEE
0-1
96
PROVIDENCE PLACE
59

As determined under the Rules and Regulations promulgated by the Commission for Health Services, Division of Health Services, North Carolina Department of Human Resources, Raleigh, North Carolina, the soils on the lot described above were found to be unsuitable for the installation of an individual septic tank - soil absorption system, due to the following reason:

Soil Drainage/Groundwater Unsuitable
Soil Permeability Unsuitable
Site Classification Unsuitable
