MECKLENBURG COUNTY
DEPARTMENT OF ENVIRONMENTAL HEALTH

APPLICATION FOR SOIL INVESTIGATION

APPENDIX II
SITE EVALUATION

SITE INVESTIGATION REPORT
INDIVIDUAL SEPTIC TANK SYSTEM
WITH SUBSURFACE,
SOIL ABSORPTION,
EFFLUENT DISCHARGE

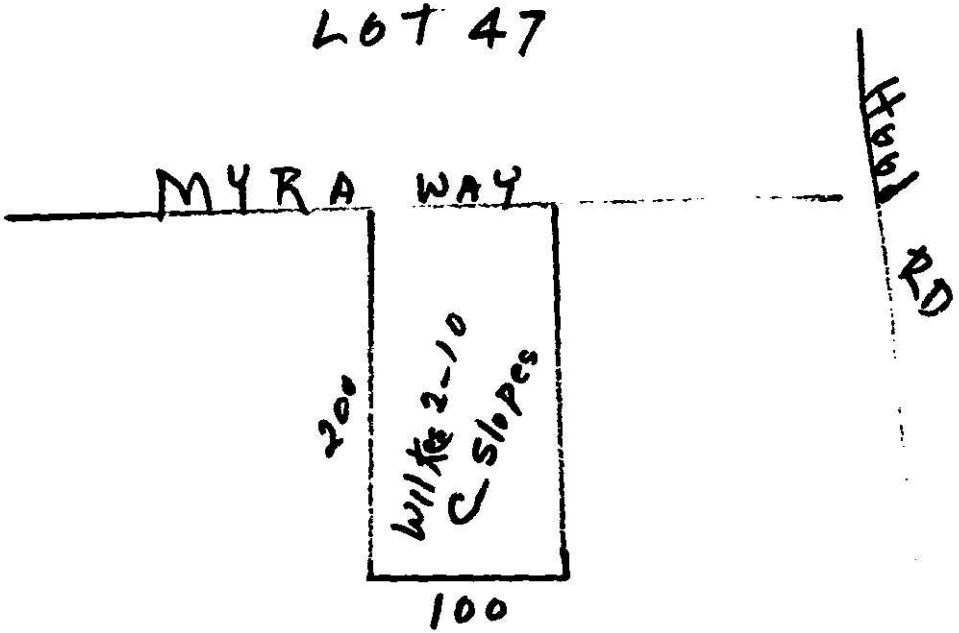
FACTORS	AREA 1	AREA 2	AREA 3	AREA 4
1. SLOPE (%)	S PS 2-10 U	S PS U	S PS U	S PS U
2. SOIL TEXTURE (12-36 in.) (Sandy loamy clayey, Note 2:1 Clay)	S PS 2:1 clay Saprolite U	S PS U	S PS U	S PS U
3. SOIL STRUCTURE (12-36 in.) (Clayey Soils)	S PS MASSIVE U	S PS U	S PS U	S PS U
4. SOIL DEPTH (In.)	S PS 48 U	S PS U	S PS U	S PS U
5. RESTRICTIVE HORIZONS (In.) (Impervious Strata Rock)	S PS Saprolite U	S PS U	S PS U	S PS U
6. SOIL DRAINAGE/CONDITION (External & Internal)	S PS Slow U	S PS U	S PS U	S PS U
7. SOIL PERMEABILITY (Percolation Rate)	S PS SLOW U	S PS U	S PS U	S PS U
8. OTHER (Specify)	S PS U	S PS U	S PS U	S PS U
9. SITE CLASSIFICATION	Unsuitable

SOIL SERIES Wilkes

LOT 47
MYRA WAY
HWY 89
200
WILL TAKE 2-10 C SLOPES
100
