APPLICATION FOR PERCOLATION TEST

SITE EVALUATION

SITE INVESTIGATION REPORT
INDIVIDUAL SEPTIC TANK SYSTEM
WITH SUBSURFACE,
SOIL ABSORPTION,
EFFLUENT DISCHARGE

LOCATION OF LOT: **Timber Ridge Drive, Lot 20, Block J**

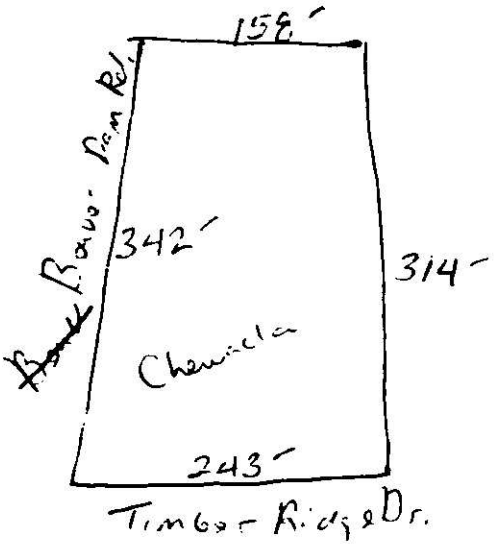
FACTORS	AREA 1	AREA 2	AREA 3	AREA 4
1. [illegible]	S PS U —	S PS U	S PS U	S PS U
2. [illegible] (12-36 in.) [illegible], loamy, clayey, [illegible])	S PS U —	S PS U	S PS U	S PS U
3. SOIL STRUCTURE (12-36 in.) [illegible] soils)	S PS U —	S PS U	S PS U	S PS U
4. [illegible] DEPTH (In.)	S PS U —	S PS U	S PS U	S PS U
5. RESTRICTIVE HORIZONS (In.) (Impervious Strata, rock)	S PS U —	S PS U	S PS U	S PS U
6. SOIL DRAINAGE (GROUNDWATER (External & Internal)	S PS U poorly drained	S PS U	S PS U	S PS U
7. SOIL PERMEABILITY (Percolation Rate)	S PS U [illegible]	S PS U	S PS U	S PS U
8. OTHER (Specify)	S PS U [illegible]	S PS U	S PS U	S PS U
9. SITE CLASSIFICATION*	Unsuitable			
SOIL SERIES	Chewacla

Recommendations/Comments: Based on this investigation, the lot was found to have soils generally unsuitable for installation of a septic tank system.

158'
Bass Pond Rd.
342'
314'
Chevrolet
243'
Timber Ridge Dr.
