MECKLENBURG COUNTY HEALTH DEPARTMENT
SITE EVALUATION REPORT
SERIAL NUMBER 16683

Location: Millview Trace Lane

Comments: 100% Repair

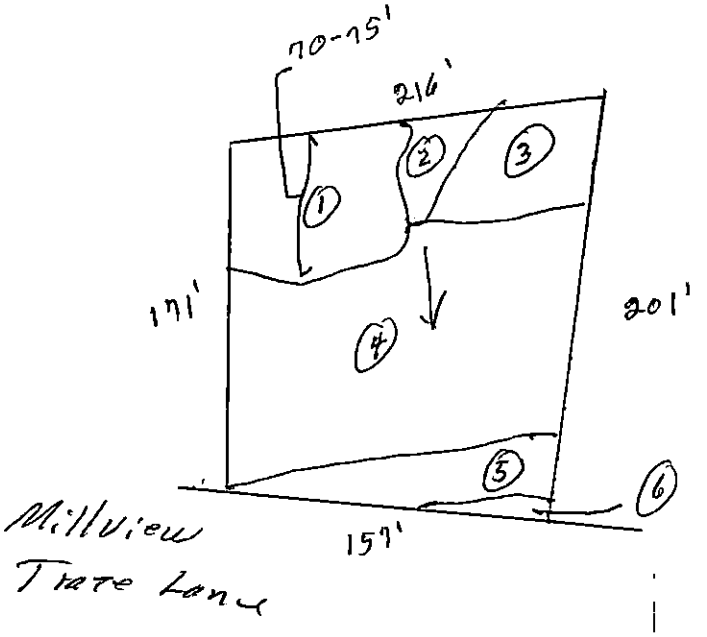
FACTORS	AREA 1	AREA 2	AREA 3	AREA 4	AREA 5	AREA 6
Topography	(S) PS U 6-12%	S PS (U) complex slopes	(S) PS U 6-12%	(S) PS U 2-8%	S PS (U) Depression	S PS U —
Texture	S (PS) U clay	S PS U —	S (PS) U clay	S PS (U) some 2:1 clay	S PS U —	S PS U —
Structure	S (PS) U Blocky	S PS U —	S (PS) U Blocky	S (PS) U Blocky	S — PS U	S PS U —
Drainage	S (PS) U >36" water	S PS U —	S (PS) U 36" to water	S PS (U) some perched water 30-36"	S PS U —	S PS U —
Depth	S (PS) U 36-38"	S PS U —	S PS (U) 32-36"	S (PS) U 36"+	S PS U —	S PS U —
Restrictive Horizons	S (PS) U >36"	S PS U —	S (PS) U 36"	S (PS) U 36"	S PS U —	S PS U —
Available Space	S PS (U) Restricted	S PS U	S PS (U) Restricted	S PS U	S PS U	S PS U —
Other (specify)	S PS U	S PS U	S PS U	S PS U	S PS U	S PS (U) Fill
Soil Group/Series	IV Cecil-Lilly	complex slopes	IV Appling-Lilly	Helena-Lilly	Depression	Fill
Area Classification	S PS (U)	S PS (U)	S PS (U)	S PS (U)	S PS (U)	S PS (U)
