APPLICATION FOR SOIL INVESTIGATION

At your request a soils investigation was conducted on the property designated above. Results of this investigation showed the site to be classified as UNSUITABLE under criteria as set forth in Section .1900 of the North Carolina Administrative Code, Title 10, Department of Human Resources, Chapter 10, Division of Health Services; Sanitary Engineering Section, Subchapter 10A, Sanitation. A copy of the Site Evaluation Report (Serial Number 11914) is enclosed.

MECKLENBURG COUNTY ENVIRONMENTAL HEALTH
SITE EVALUATION REPORT
SERIAL NUMBER

Location: E. Mallard Creek Church Road

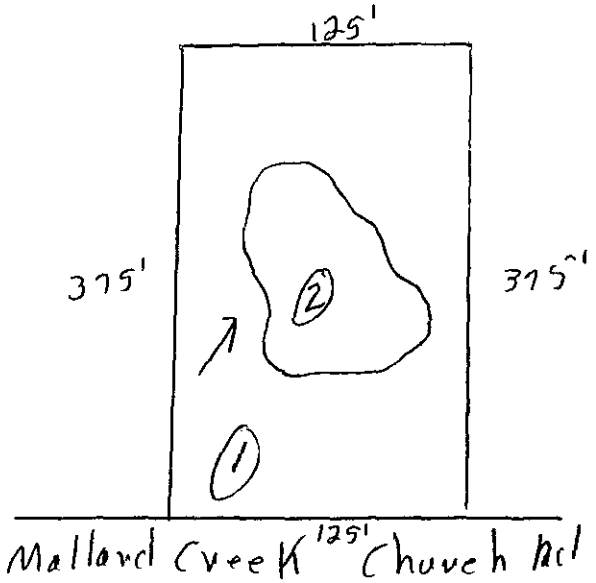
The soil on this property is not suitable for use with any conventional, modified or alternative system of which I am aware.

FACTORS	AREA 1	AREA 2	AREA 3	AREA 4	AREA 5	AREA 6
Topography	(S) PS U 2-10%	S PS U —	S PS U	S PS U	S PS U	S PS U
Texture	S PS (U) 2-1C clay	S PS U —	S PS U	S PS U	S PS U	S PS U
Structure	S (PS) U Blocky	S PS (U) compacted	S PS U	S PS U	S PS U	S PS U
Drainage	S PS (U) perched water 6-12"	S PS U —	S PS U	S PS U	S PS U	S PS U
Depth	S PS (U) 18-36"	S PS U	S PS U	S PS U	S PS U	S PS U
Restrictive Horizons	S (PS) U 7-36"	S PS U	S PS U	S PS U	S PS U	S PS U
Available Space	S (PS) U	S PS U	S PS U	S PS U	S PS U	S PS U
Other (specify)	S PS U	S PS (U) Fill	S PS U	S PS U	S PS U	S PS U
Soil Group/Series	IVB Helena-Lilo	Fill / IVB Helena-Lilo				
Area Classification	S PS (U)	S PS (U)	S PS U	S PS U	S PS U	S PS U
