MECKLENBURG COUNTY HEALTH DEPARTMENT

SOIL INVESTIGATION REPORT

Date of Investigation June 15, 1977 APT NO. 12591

SITE INVESTIGATION REPORT
INDIVIDUAL SEPTIC TANK SYSTEM
WITH SUBSURFACE,
SOIL ABSORPTION,
EFFLUENT DISCHARGE

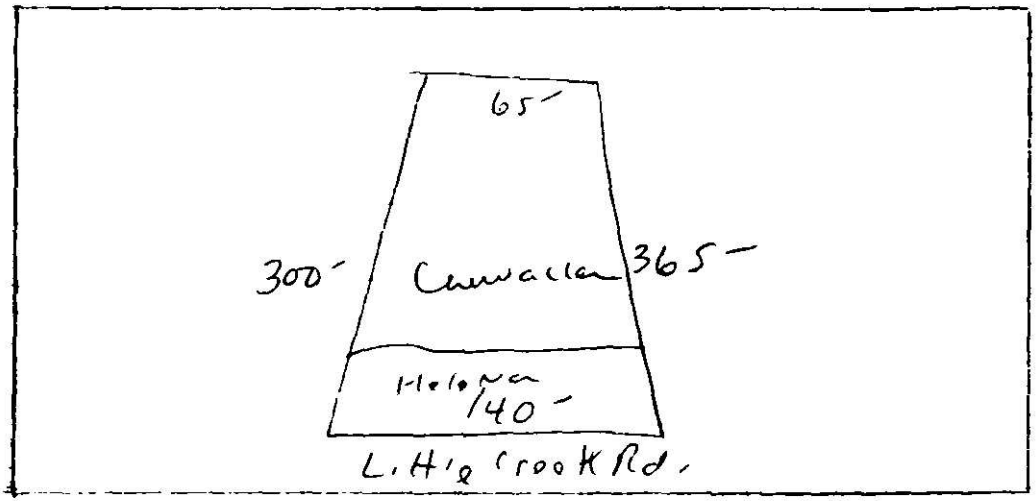
DIAGRAM OF PROPERTY

Soil Properties	Soil 1	Soil 2	Soil 3	Soil 4
1. Soil Series	Helena		Chewacla	
2. Soil Slope	Suitable 2-6%		—	
3. Soil Depth	unsuitable <48"		—	
4. Soil Texture	unsuitable 2:1 expanding clays		—	
5. Soil Structure	unsuitable massive		—	
6. Restrictive Horizons	—		—	
7. Soil Drainage	unsuitable perched high water table		unsuitable poorly drained	
8. Soil Permeability (Percolation Rate)	unsuitable very slow >200 min./in.		unsuitable seasonal high water table <18" from surface	
9. Other	—		unsuitable floods	
10. Overall Rating	unsuitable		unsuitable

Recommendations Based on this investigation, the lot was found to have soils dominantly unsuitable for installation of a septic tank system.
