APPLICATION FOR SOIL INVESTIGATION

APPENDIX II
SITE EVALUATION

SITE INVESTIGATION REPORT
INDIVIDUAL SEPTIC TANK SYSTEM
WITH SUBSURFACE,
SOIL ABSORPTION,
EFFLUENT DISCHARGE

LOCATION OF LOT Plaza Road extension at Plaza Park Drive Lot B

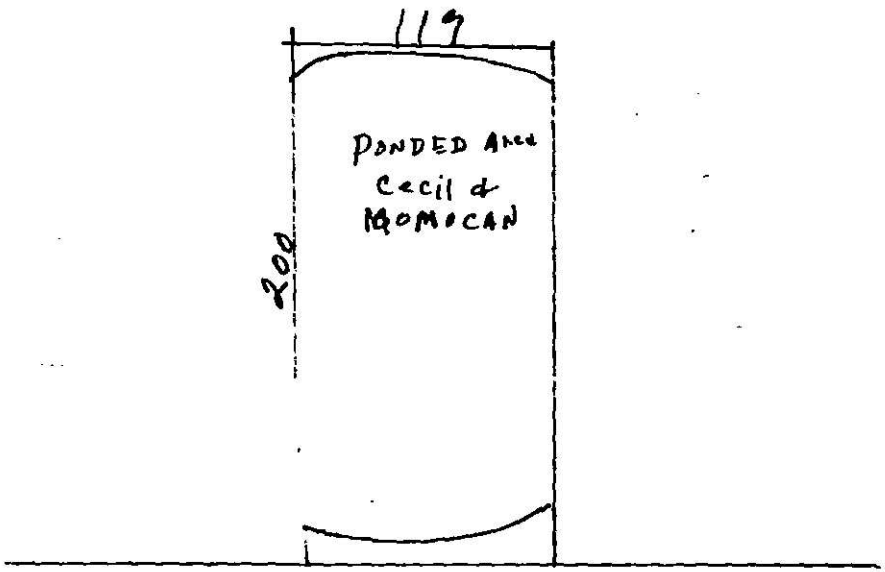
Recommendations/Comments: MAIN Problem SEEM To Be Caused By Water Being Dammed By Rd

119
PONDED AREA
Cecil & MOMOCAN
200
