APPLICATION FOR SOIL INVESTIGATION

A pre-preliminary investigation of soils and topography was made on the tracts (029-231-03 and 029-221-03) located on Ridge Road. A soils map was prepared and a copy is enclosed.

Pre-Preliminary 029-231-03, 029-221-03

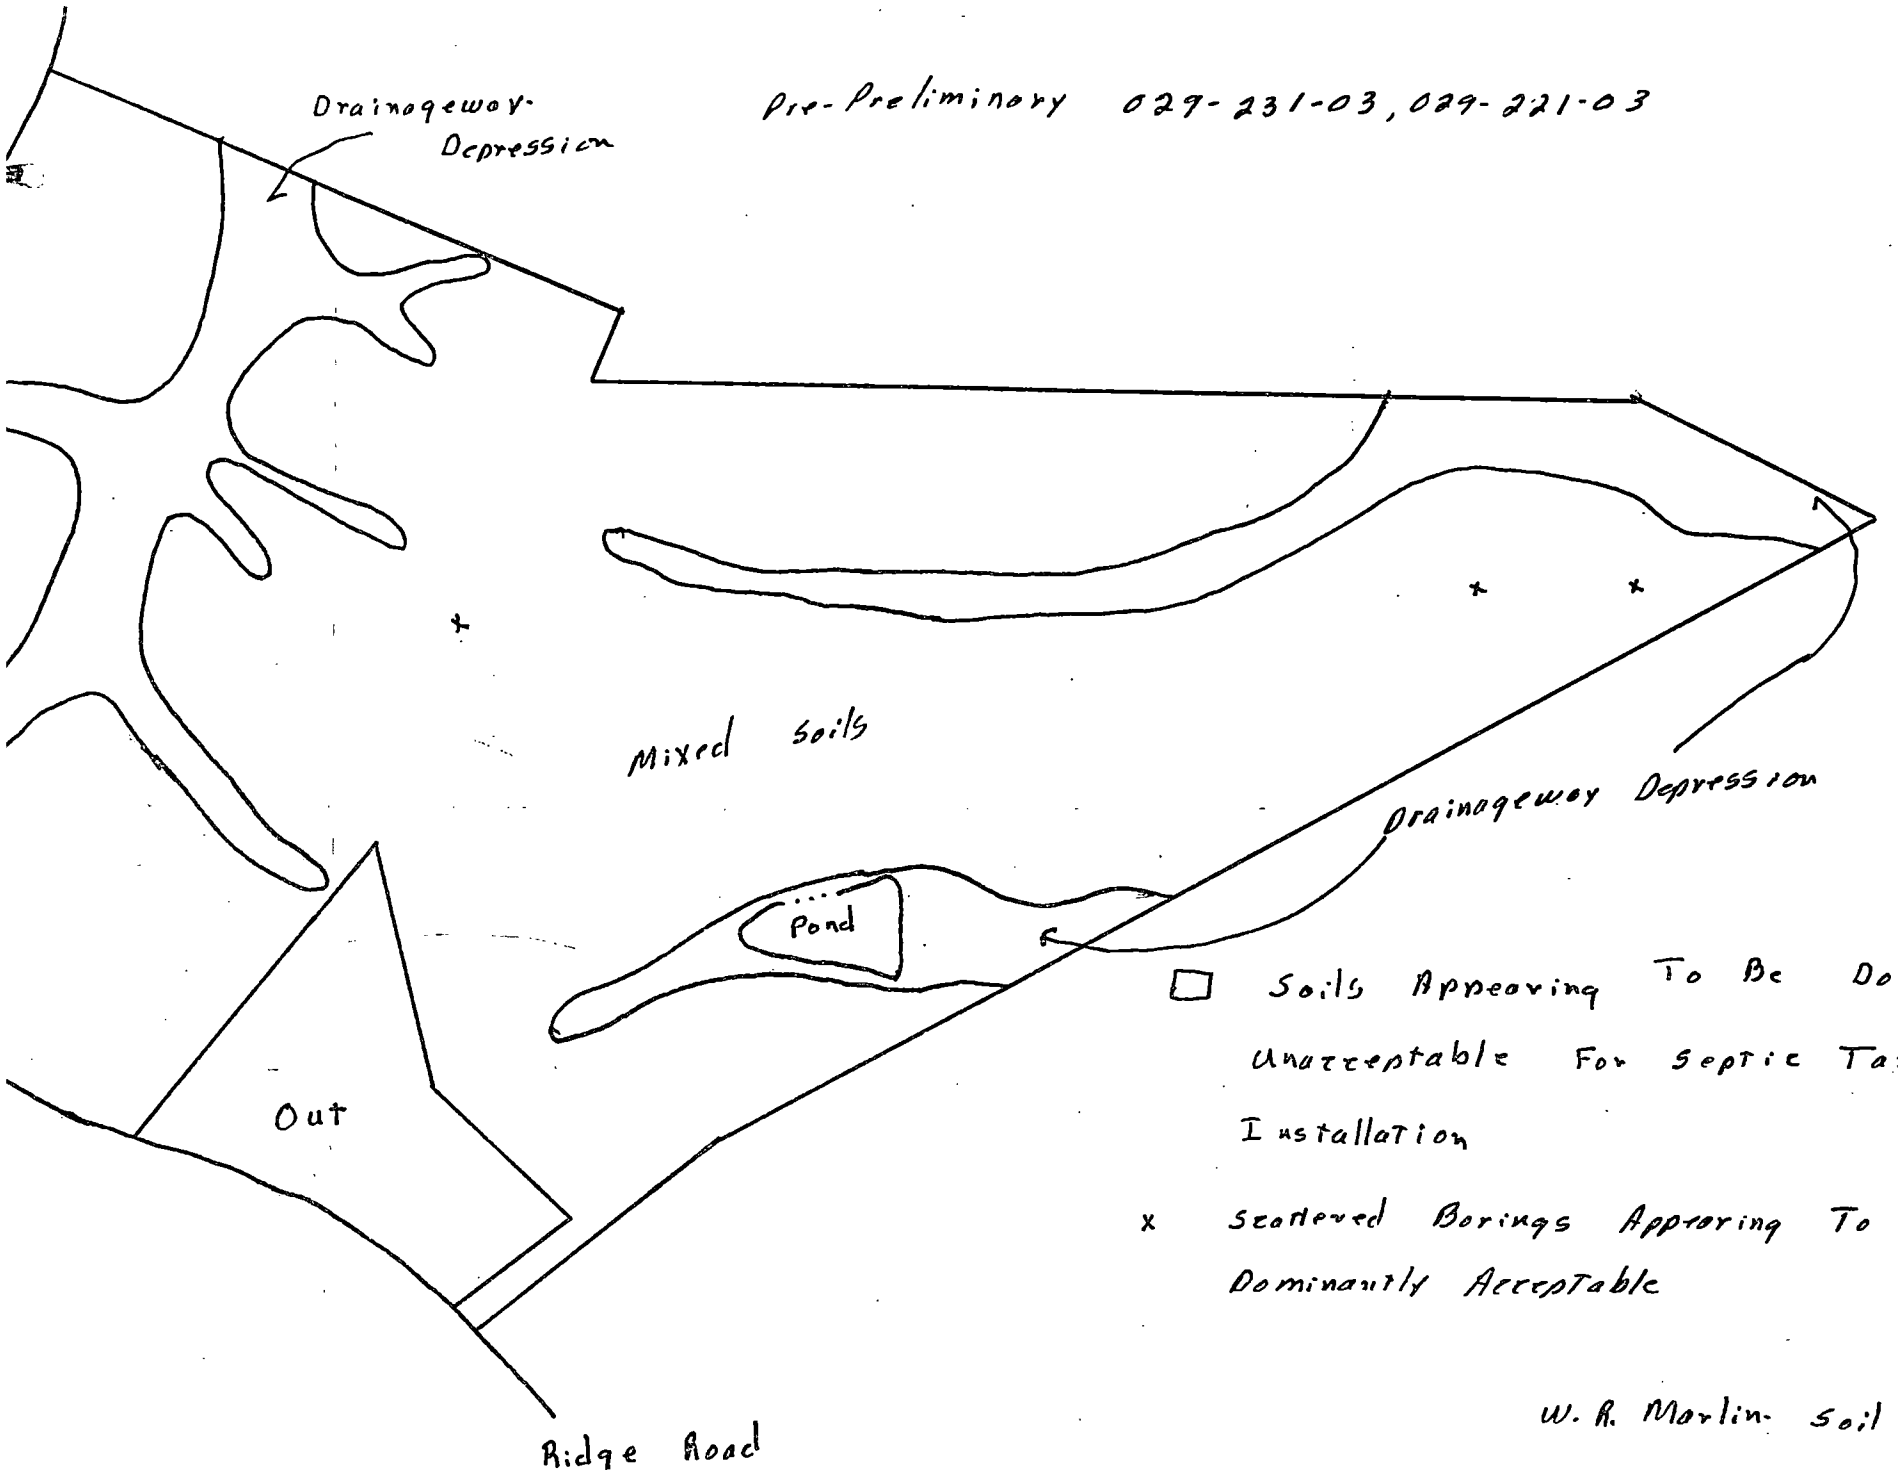
The unshaded areas on the enclosed map represent mixed soils that appear to be dominantly unacceptable for the installation of septic tank systems. Soil conditions noted are as follows: soils with expanding clay, shallow depth, and seasonal perched water; drainageway areas and complex slopes.

Most of the soils on the tracts have expanding clay present. This material swells when wet, reducing soil pore space and inhibiting natural water movement through the soil profile. Subsoil horizons are of a clay texture and are blocky with respect to structure. These soils can be very shallow with saprolite occurring as shallow as twelve inches. Perched water is quite common in these soils as well, occurring as shallow as eight inches. Slopes range to approximately fifteen percent.

The drainageway areas collect and channel surface water runoff from surrounding land areas. These areas would be subject to some surface flooding during periods of precipitation. The soils in the flat areas of the drainageway, are subject to seasonal water at depth of less than thirty-six inches.

A few complex slope areas have irregular, eroded slopes that are not adaptable for the installation of septic tank systems.

Some scattered borings of soils appearing to be dominantly acceptable were found on the tract. These soils have clay subsoils with blocky structure. Depth to ground water is greater than thirty-six inches. Saprolite depth ranges to approximately thirty-six inches but may be shallower. Slopes range to approximately twelve percent. These soil areas did not appear to be large enough to delineate at the time of this investigation. A more intensive investigation would be needed to determine more accurately the extent of these soils. The approximate locations of the borings are marked.

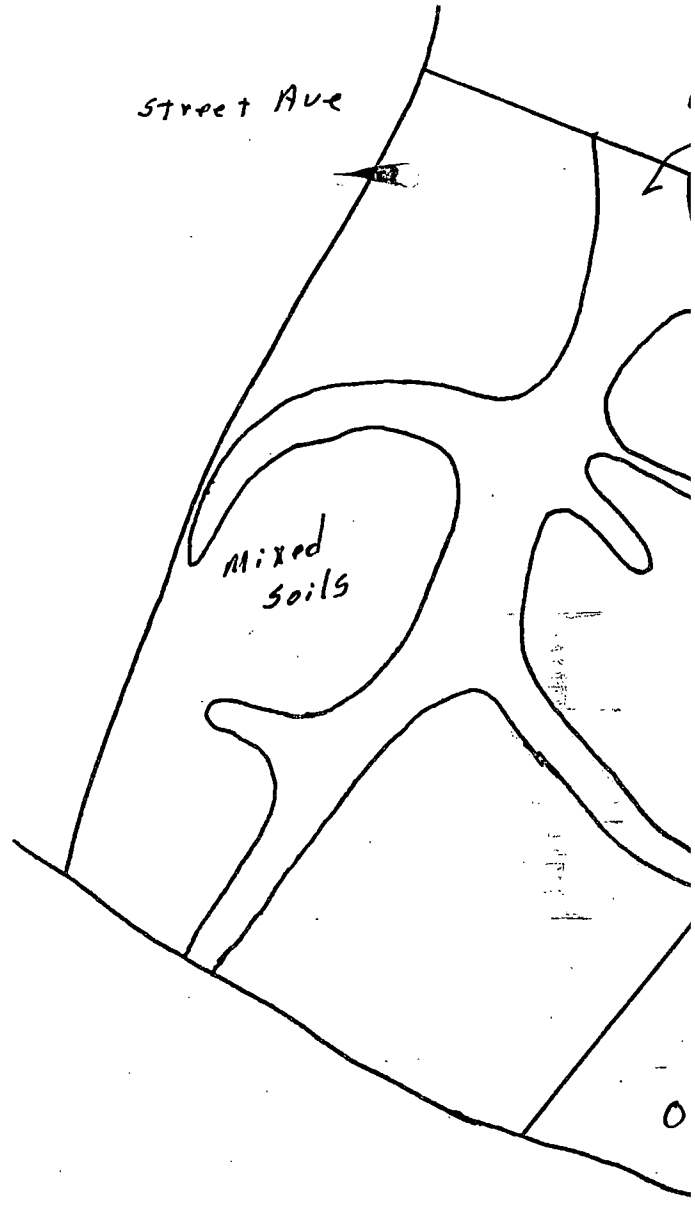
Based on this investigation, the majority of the soils on the two tracts appear to be dominantly unacceptable for the installation of septic tank systems. Please note that this report does not express or imply that sufficient areas of acceptable soils for septic tank system installation are present. Soil delineations may be subject to change pending additional investigation with established reference points. Inclusions of soils other than those delineated may be present. Individual lot approval is dependent in part on the satisfactory completion of an investigation of the specific lot or site. No lots are currently marked on the tract. Please contact me if there are any questions with regard to this report.
