OPERATION PERMIT for an ON-SITE WASTEWATER TREATMENT & DISPOSAL SYSTEM

Job Location Address: 12035 Jumper Dr.

OPERATION PERMIT for an
ON-SITE WASTEWATER TREATMENT & DISPOSAL SYSTEM

SOIL/SITE EVALUATION
for ON-SITE WASTEWATER SYSTEM

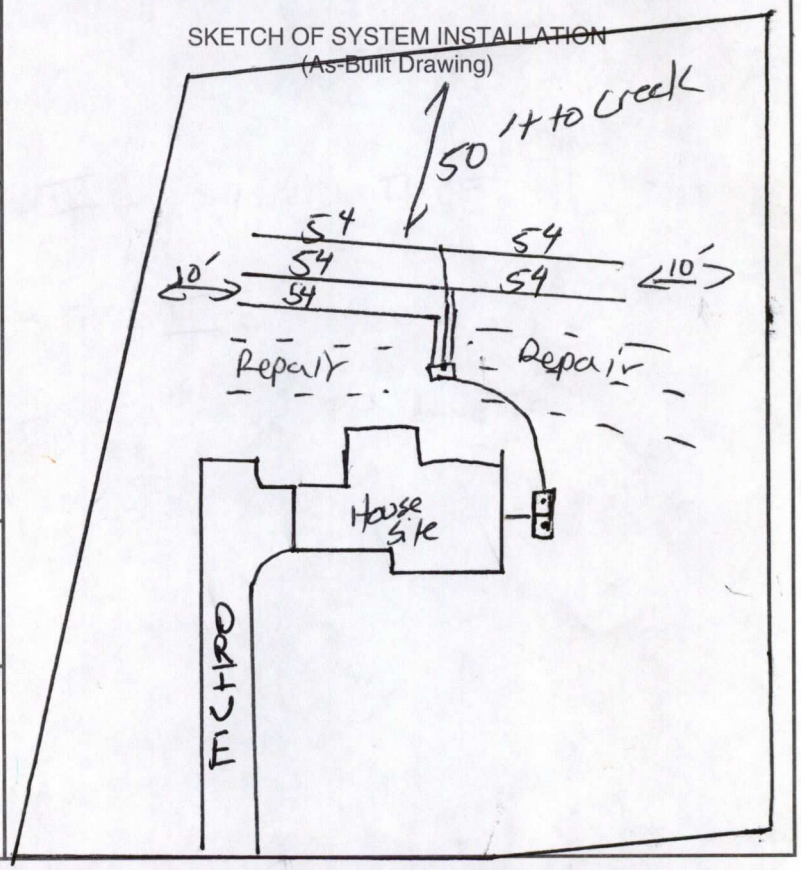
SKETCH OF SYSTEM INSTALLATION
(As-Built Drawing)

Comments: System Classification & Type: Gravity PANEL SYSTEM IIIc
