APPLICATION FOR SOIL INVESTIGATION

SOIL INVESTIGATION REPORT

SITE INVESTIGATION REPORT
INDIVIDUAL SEPTIC TANK SYSTEM
WITH SUBSURFACE,
SOIL ABSORPTION,
EFFLUENT DISCHARGE

LOCATION OF LOT Norwich Road, Lot Q, Block B

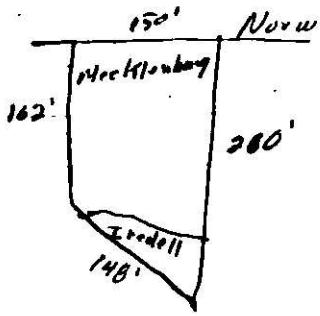
Soil Properties	Soil 1	Soil 2	Soil 3	Soil 4
1. Soil Series	Mac Hlenberg	Iredell		
2. Soil Slope	Suitable 2-6%	Suitable 2-6%		
3. Soil Depth	Suitable 48"	unsuitable < 36"		
4. Soil Texture	unsuitable 2-1 Expandy clay	unsuitable 2-1 Expandin clay		
5. Soil Structure	unsuitable Massive	unsuitable Massive		
6. Restrictive Horizons				
7. Soil Drainage	Suitable water Table >6'	unsuitable perched high water Table		
8. Soil Permeability (Percolation Rate)	unsuitable slow >20 min/in	unsuitable v. slow >20 min/in		
9. Other				
10. Overall Rating	unsuitable	unsuitable

Remarks Recommendations Based on the investigation, the soils on the lot were found to be unsuitable for installation of a septic tank system.

150'
Norwith Rd
Mecklenburg
162'
260'
Tisdell
148'
