MECKLENBURG COUNTY
DEPARTMENT OF ENVIRONMENTAL HEALTH

APPLICATION FOR SOIL INVESTIGATION

APPENDIX H
SITE EVALUATION

SITE INVESTIGATION REPORT
INDIVIDUAL SEPTIC TANK SYSTEM
WITH SUBSURFACE,
SOIL ABSORPTION,
EFFLUENT DISCHARGE

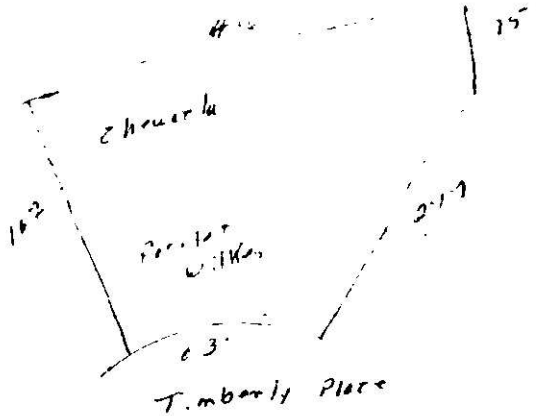
FACTORS	AREA 1	AREA 2	AREA 3	AREA 4
1. SLOPE (%)	(S) PS 6-15% U	S PS — U	S PS U	S PS U +
2. SOIL TEXTURE (12-36 in.) (Sandy, loamy, clayey, Note 2:1, Clay)	S (PS) clay U	S PS — U	S PS U	S PS U
3. SOIL STRUCTURE (12.36 in.) (Clayey Soils)	S (PS) 3c-Ky U	S PS — U	S PS U	S PS U
4. SOIL DEPTH (In.)	S Saprolite PS @ 24" (U)	S PS — U	S PS U	S PS U
5. RESTRICTIVE HORIZONS (In. (Inprevious Strata, Rock)	S PS — U	S PS — U	S PS U	S PS U
6. SOIL DRAINAGE/GROUNDWATER (External & Internal)	(S) To Fair PS water U Table	S Seasonal PS perched (U) water Table	S PS U	S PS U
7. SOIL PERMEABILITY (Percolation Rate)	S Slow PS Fair (U) Poor	S Subject PS To flood. (U)	S PS U	S PS U
8. OTHER (Specify)	S PS U	S PS U	S PS U	S PS U
9. SITE CLASSIFICATION	unsuitable	unsuitable		
SOIL SERIES	Pacolet w. Mas	Chewacla

* See Diagram on Back (Include: Soil areas, property lines, roads, streams, gullies, wet areas, fill areas, wells, water bodies, slope patterns, etc)

Recommendations/Comments: Based on the investigation, site is not considered to be suitable for the installation of a septic tank system
