MECKLENBURG COUNTY HEALTH DEPARTMENT

APPLICATION FOR PERCOLATION TEST

SOIL INVESTIGATION REPORT

SITE INVESTIGATION REPORT
INDIVIDUAL SEPTIC TANK SYSTEM
WITH SUBSURFACE,
SOIL ABSORPTION,
EFFLUENT DISCHARGE

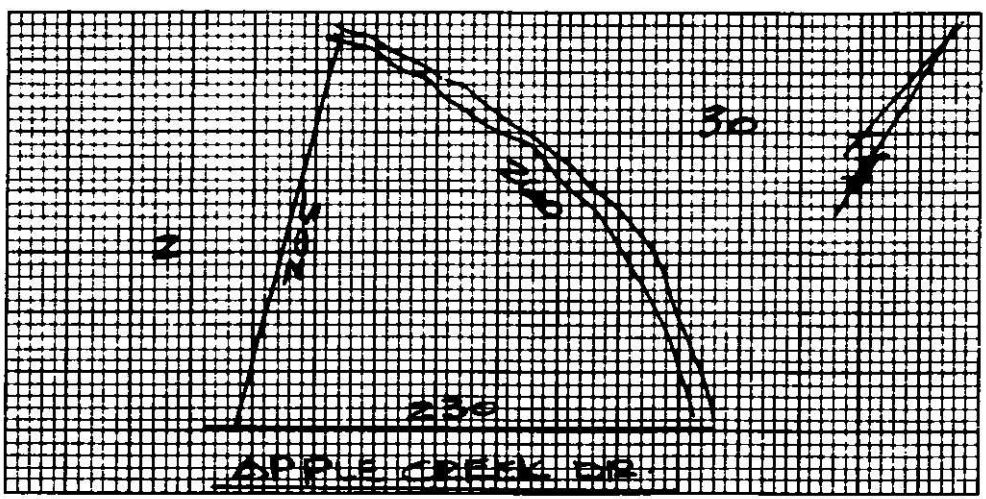
7) ACCURATELY DIAGRAM & DIMENSION LOT

Soil Properties	Soil 1	Soil 2	Soil 3	Soil 4
1. Soil Series	Helvetia		Chehalis	
2. Soil Slope	suitable 2-6%		—	
3. Soil Depth	unsuitable <46"		—	
4. Soil Texture	unsuitable 2.1 clay S		—	
5. Soil Structure	unsuitable massive		—	
6. Restrictive Horizons	—		—	
7. Soil Drainage	unsuitable perched high water table		unsuitable poorly drained	
8. Soil Permeability (Percolation Rate)	unsuitable very slow >200 min/in.		unsuitable seasonal	high water table < 18" from surface
9. Other	—		unsuitable floods	
10. Overall Rating	unsuitable		unsuitable

Recommendations Based on this investigation, the lot was found to have soils dominantly unsuitable for installation of a septic tank system.

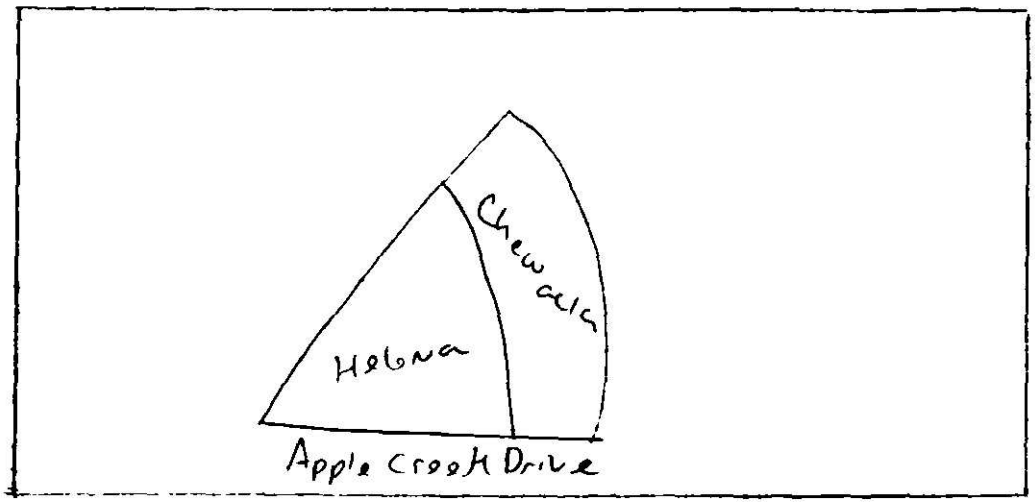
DIAGRAM OF PROPERTY

The lot described above is not recommended for the installation of an individual septic tank system with subsurface, soil absorption, effluent discharge due to the following:

Soil Structure Unsuitable.

Soil Permeability Unsuitable.
