"INDIVIDUAL SEPTIC TANK SYSTEMS"

APPLICATION FOR SOIL INVESTIGATION

SOIL INVESTIGATION REPORT

SITE INVESTIGATION REPORT
INDIVIDUAL SEPTIC TANK SYSTEM
WITH SUBSURFACE,
SOIL ABSORPTION,
EFFLUENT DISCHARGE

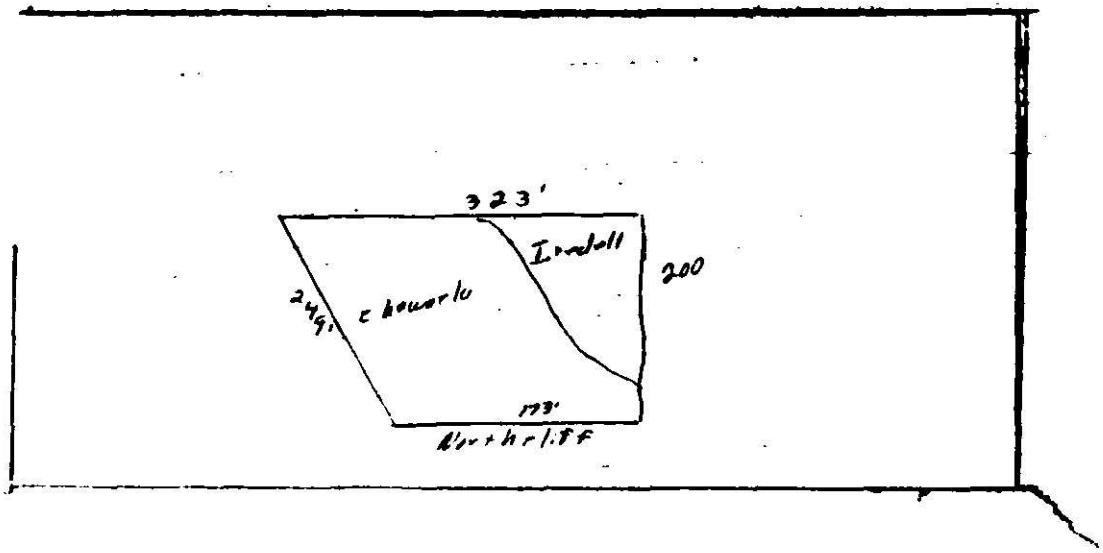
DIAGRAM OF PROPERTY

Soil Properties	Soil 1	Soil 2	Soil 3	Soil 4
1. Soil Series	Cheswold	Ingleside		
2. Soil Slope	—	suitable 2-8%		
3. Soil Depth	—	unsuitable <40"		
4. Soil Texture	—	unsuitable 2:1 Expanding clay		
5. Soil Structure	—	unsuitable massive		
6. Restrictive Horizons	—	—		
7. Soil Drainage	unsuitable poorly drained	unsuitable perched high water Table		
8. Soil Permeability (Percolation Rate)	unsuitable seasonal high water table 18" from surface subject to flooding	unsuitable slow-very slow percolation		
9. Other				
10. Overall Rating	unsuitable	unsuitable

Remarks; Recommendations: Based on this investigation, the soils on the lot were found to be predominately unsuitable for installation of a septic tank system.

Soil permeability unsuitable

Percolation rate in excess of 200Min./in.
