APPLICATION FOR SOIL INVESTIGATION

SITE INVESTIGATION REPORT
INDIVIDUAL SEPTIC TANK SYSTEM
WITH SUBSURFACE,
SOIL ABSORPTION,
EFFLUENT DISCHARGE

LOCATION OF LOT: **Merrymount Drive, Lot 7, Block 191**

SOIL INVESTIGATION REPORT

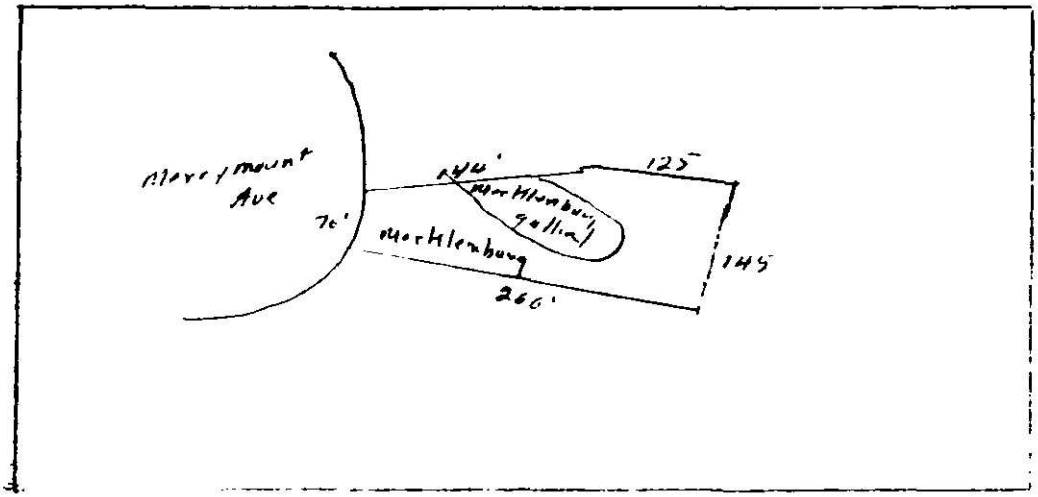
DIAGRAM OF PROPERTY

Remarks ~~Recommendations~~ Based on the investigation, this lot was found to be unsuitable for the installation of a septic tank system.
