MECKLENBURG COUNTY HEALTH DEPARTMENT

APPLICATION FOR PERCOLATION TEST

SITE DISAPPROVAL REPORT
INDIVIDUAL SEPTIC TANK SYSTEM WITH SUBSURFACE,
SOIL ABSORPTION, EFFLUENT DISCHARGE

LOCATION OF LOT Mountainview Drive, Lot 26

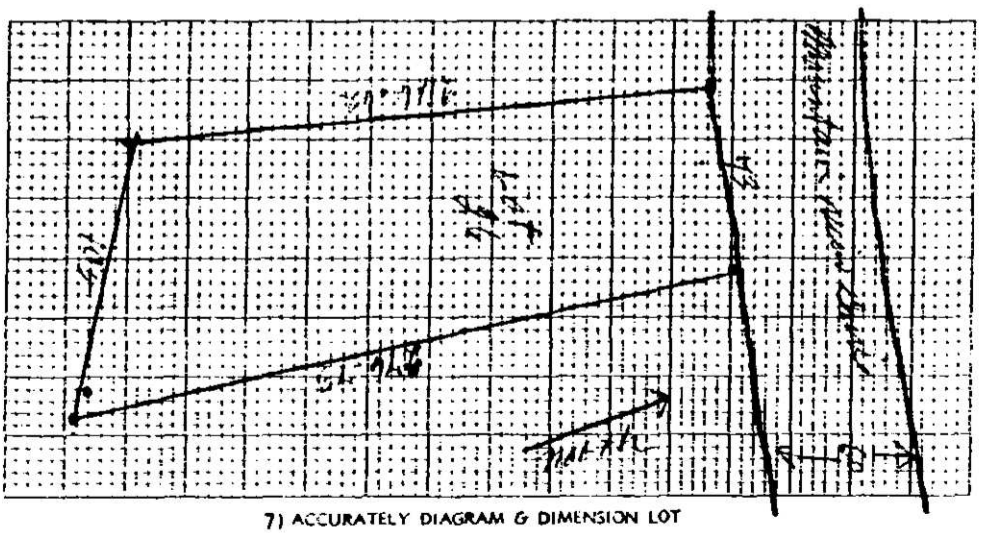
7) ACCURATELY DIAGRAM & DIMENSION LOT

X ON SITE INSPECTION REVEALED LOT TO BE UNSUITABLE FOR THE FOLLOWING REASON(S) 2-25-74 Soils were found to be a shallow phase of the Pacolet series. These soils are extremely shallow to rock material. The depth to rock varies from 5 to about 4 feet. These soil characteristics impose extreme physical limitations on the installation of sy[illegible] potential for lateral seepage of effluent resulting in the wastes coming to the soil surface.
