MECKLENBURG COUNTY HEALTH DEPARTMENT

APPLICATION FOR PERCOLATION TEST

APPENDIX H
SITE EVALUATION

SITE INVESTIGATION REPORT
INDIVIDUAL SEPTIC TANK SYSTEM
MISS SUBSURFACE,
SOIL ABSORPTION,
EFFLUENT DISCHARGE

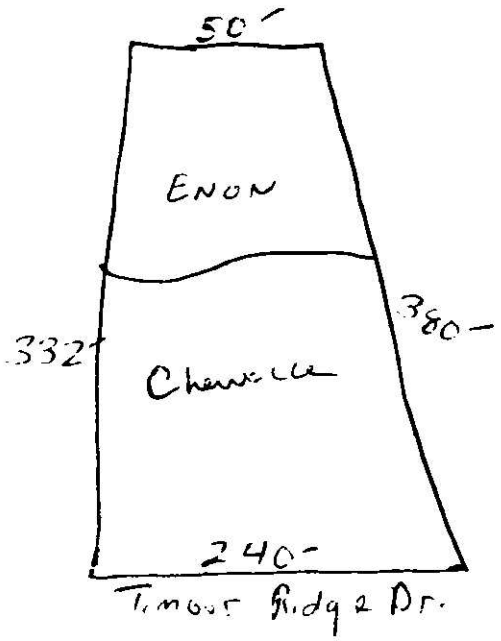
FACTORS	AREA 1	AREA 2	AREA 3	AREA
[illegible]	S PS U —	S PS 3-6' U	S PS U	S PS U
[illegible] (12-36 in.) [illegible], clayey, [illegible])	S PS U —	S PS U Silty	S PS U	S PS U
[illegible] STRUCTURE (12-36 in.) [illegible] soils)	S PS U —	S PS U Massive	S PS U	S PS U
[illegible] WIDTH (In.)	S PS U —	S PS U 48+	S PS U	S PS U
[illegible] HORIZONS (In.) [illegible] Strata, rock)	S PS U —	S PS U —	S PS U	S PS U
[illegible] DRAINAGE, GROUNDWATER (External & Internal)	S PS U Poorly Drained	S PS U Perched high water table	S PS U	S PS U
[illegible] PERMEABILITY [illegible] Percolation Rate)	S PS U Seasonal high water table	S PS U 72 min/in	S PS U	S PS U
[illegible] (Specify)	S PS U floods	S PS U —	S PS U	S PS U
[illegible] CLASSIFICATION*	unsuitable	unsuitable		
[illegible]	Chewacla	Enon

[illegible] Recommendations/Comments: Based on this investigation the lot was found to have soils generally unsuitable for installation of septic tank systems.

50'
ENON
380-
332'
Chevelle
240-
Timber Ridge Dr.
