Mecklenburg County
Health Department

RE: Property located at Danby Subdivision
FILE: 6999A
PARCEL: PO 223-012-06

MECKLENBURG COUNTY HEALTH DEPARTMENT
SITE EVALUATION REPORT
SERIAL NUMBER 16665

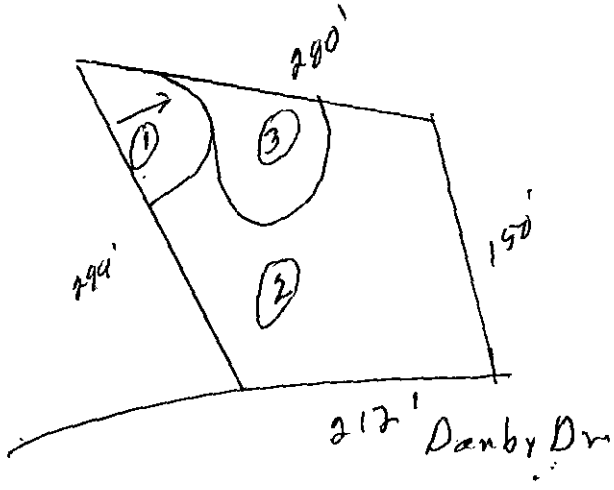
Comments: 100% Repair

FACTORS	AREA 1	AREA 2	AREA 3	AREA 4	AREA 5	AREA 6
Topography	S (PS) U 10-25%	S PS (U) complex slopes	S PS (U) Drainageway Depression	S PS U	S PS U	S PS U
Texture	S (PS) U Clay	S PS U —	S PS U —	S PS U	S PS U	S PS U
Structure	S (PS) U Blocky	S PS U —	S PS U —	S PS U	S PS U	S PS U
Drainage	S (PS) U >36" to water	S PS U —	S PS U —	S PS U	S PS U	S PS U
Depth	S (PS) U 40"+	S PS U —	S PS U —	S PS U	S PS U	S PS U
Restrictive Horizons	S (PS) U 740"	S PS U —	S PS U —	S PS U	S PS U	S PS U
Available Space	S PS (U) Restricted	S PS U —	S PS U —	S PS U	S PS U	S PS U
Other (specify)	S PS U	S PS U	S PS U	S PS U	S PS U	S PS U
Soil Group/Series	IV Cecil/Lilo	Complex slopes	Drainageway Depression			
Area Classification	S PS (U)	S PS (U)	S PS (U)	S PS U	S PS U	S PS U
