APPLICATION FOR SOIL INVESTIGATION

5) SUBDIVISION East Providence Estates LOT NO. 9 BLOCK NO. 6

APPENDIX II
SITE EVALUATION

SITE INVESTIGATION REPORT
INDIVIDUAL SEPTIC TANK SYSTEM
WITH SUBSURFACE,
SOIL ABSORPTION,
EFFLUENT DISCHARGE

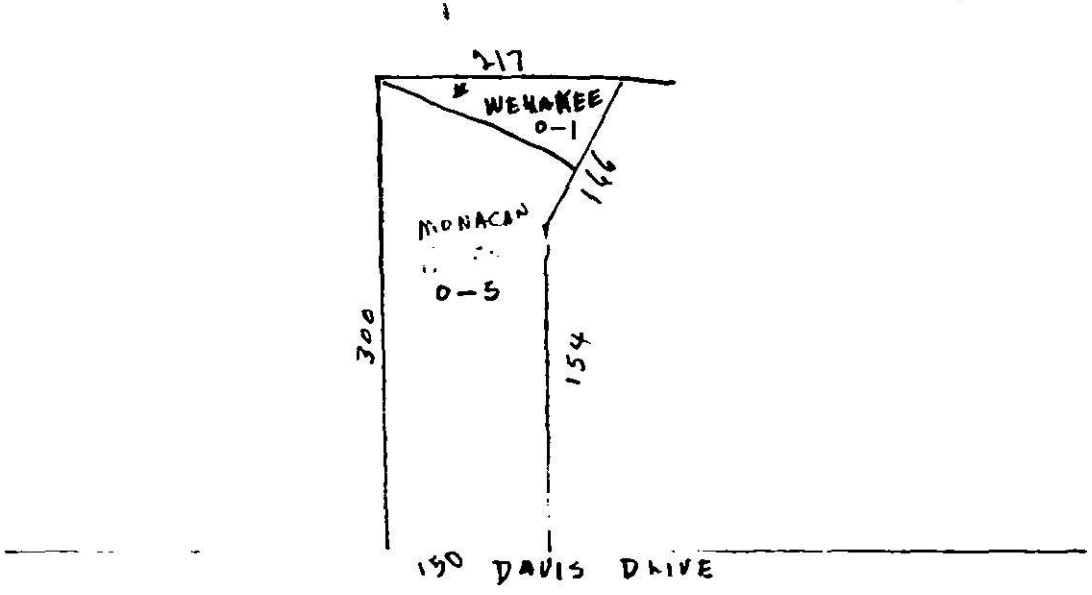
FACTORS	AREA 1	AREA 2	AREA 3	AREA 4
1. SLOPE (%)	S (PS) U 2-5	S PS (U) 0-2	S PS U	S PS U
2. SOIL TEXTURE (12-36 in.) (Sandy, loamy, clayey, Note 2:1 Clay)	S (PS) U clayey Sandy Loam	S (PS) U clay Sandy loam	S PS U	S PS U
3. SOIL STRUCTURE (12.36 in.) (Clayey Soils)	S PS (U) Blocky To Massive	S PS (U) Blocky To Massive	S PS U	S PS U
4. SOIL DEPTH (In.)	S PS (U) <48	S PS (U) <48	S PS U	S PS U
5. RESTRICTIVE HORIZONS (In.) (Impervious Strata, Rock)	S PS (U) clay Hard Pan	S PS (U) clay	S PS U	S PS U
6. SOIL DRAINAGE/GROUNDWATER (External & internal)	S PS (U) High Water Table	S PS (U) Flooded	S PS U	S PS U
7. SOIL PERMEABILITY (Percolation Rate)	S (PS) U slow	S PS (U) slow	S PS U	S PS U
8. OTHER (Specify)	S PS U	S PS U	S PS U	S PS U
9. SITE CLASSIFICATION	unsuitable	unsuitable		
SOIL SERIES	MONACAN ne	Wehadkee (SWAMP)

217
WEHAKEE
O-1
166
MONACAN
O-5
300
154
150 DAVIS DRIVE

Soil Drainage/Groundwater Unsuitable (highwater table)

Soil Permeability Unsuitable
