MECKLENBURG COUNTY HEALTH DEPARTMENT

APPLICATION FOR PERCOLATION TEST

SUBJECT: APT #6303 (Waco Realty Co.)
Lot No. 54 on Powell Street
8-31-73

SOIL INVESTIGATION REPORT

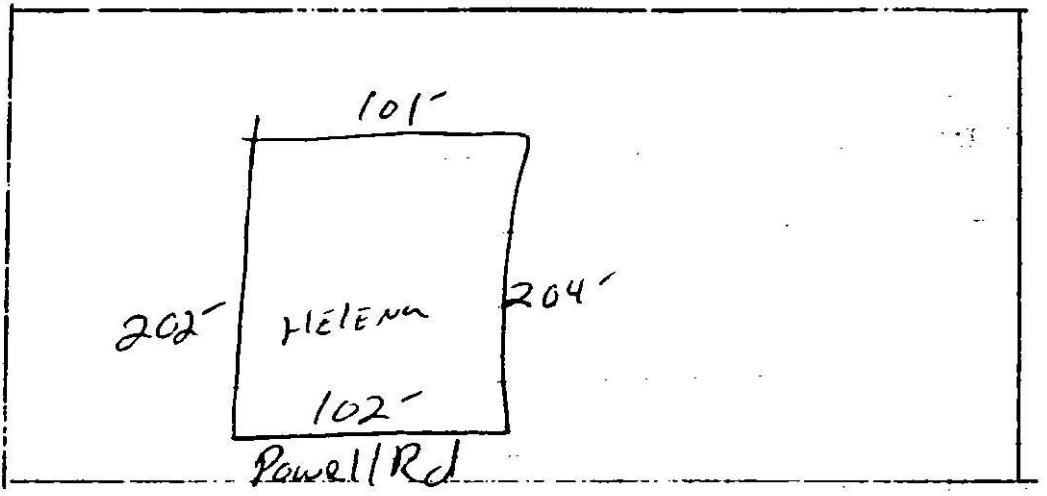
DIAGRAM OF PROPERTY

Soil Properties	Soil 1	Soil 2	Soil 3	Soil 4
1. Soil Series	Helena			
2. Soil Slope	unsuitable depression			
3. Soil Depth	suitable 48"+			
4. Soil Texture	unsuitable silt/expanding clay			
5. Soil Structure	unsuitable massive			
6. Restrictive Horizons	—			
7. Soil Drainage	unsuitable perched high water table			
8. Soil Permeability (Percolation Rate)	unsuitable very slow >200 min/in			
9. Other	—			
10. Overall Rating	unsuitable

Soil Permeability unsuitable

Percolation rate in excess of 200 min./in.

Recommendations Based on this investigation, the lot is not recommended for approval for installation of a septic tank system.
