MECKLENBURG COUNTY
DEPARTMENT OF ENVIRONMENTAL HEALTH

SOIL INVESTIGATION REPORT

SITE INVESTIGATION REPORT
INDIVIDUAL SEPTIC TANK SYSTEM
WITH SUBSURFACE,
SOIL ABSORPTION,
EFFLUENT DISCHARGE

LOCATION OF LOT Brief Road, Lot 9, Block 223

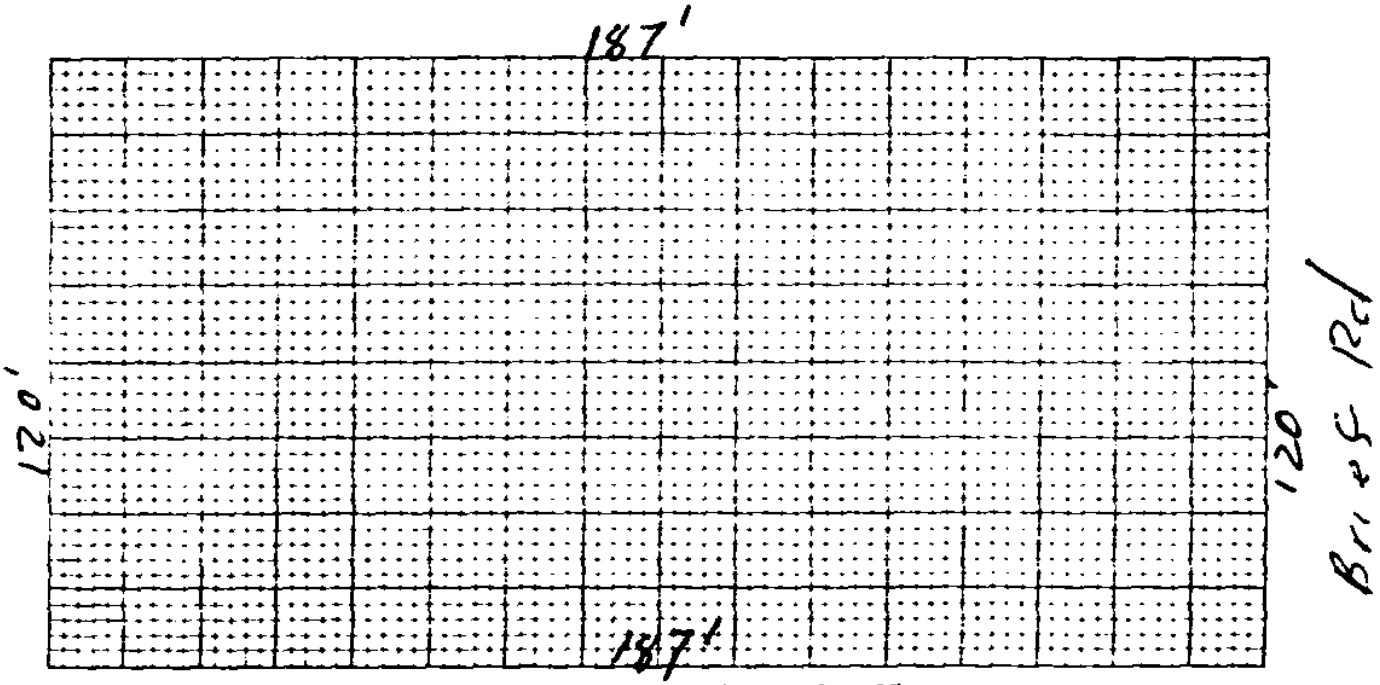
7) ACCURATELY DIAGRAM & DIMENSION LOT

22,440 sq. ft.

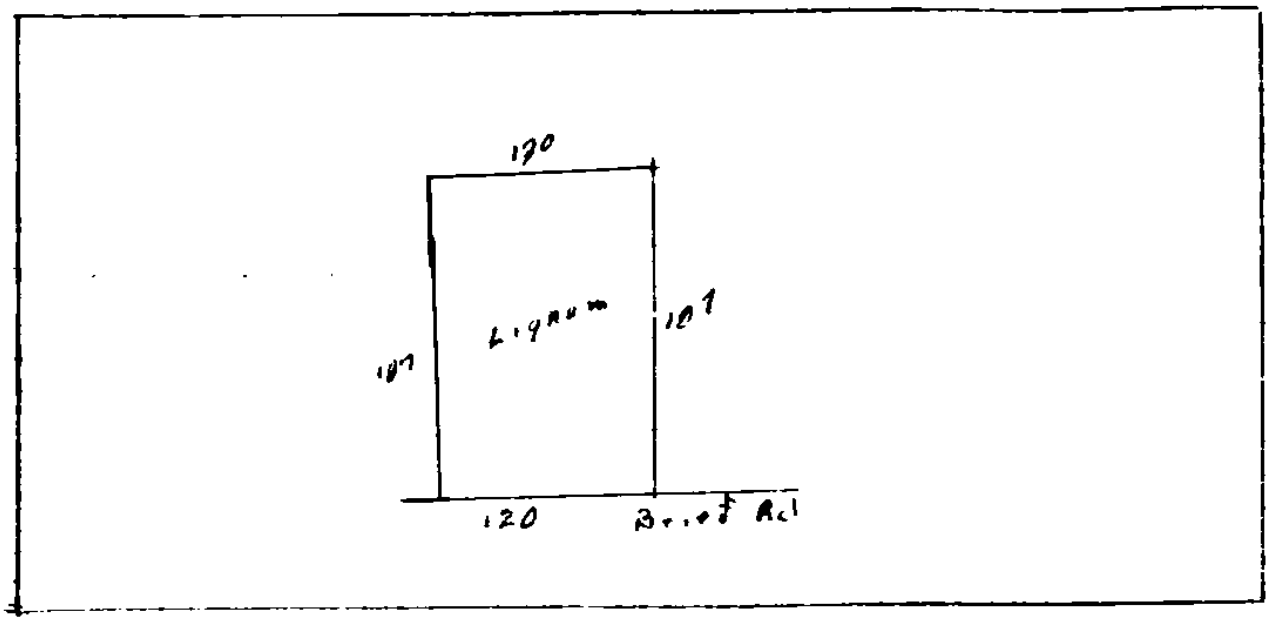
DIAGRAM OF PROPERTY

Soil Properties	Soil 1	Soil 2	Soil 3	Soil 4
1. Soil Series	Lyman			
2. Soil Slope	Suitable 2-6%			
3. Soil Depth	unsuitable < 36"			
4. Soil Texture	unsuitable 2:1 [illegible] clay			
5. Soil Structure	unsuitable [illegible] platy			
6. Restrictive Horizons				
7. Soil Drainage	Suitable water table 72"			
8. Soil Permeability (Percolation Rate)	unsuitable V. Slow >200 min/in			
9. Other				
10. Overall Rating	unsuitable

Recommendations Based on the investigation, the soils on the lot were found to be unsuitable for the installation of a septic tank system.

The lot described above is not recommended for the installation of an individual septic tank system with subsurface, soil absorption, effluent discharge due to the following:

Soil Structure Unsuitable.

Soil Permeability Unsuitable.
