MECKLENBURG COUNTY HEALTH DEPARTMENT

SOIL INVESTIGATION REPORT

SITE INVESTIGATION REPORT
INDIVIDUAL SEPTIC TANK SYSTEM
WITH SUBSURFACE,
SOIL ABSORPTION,
EFFLUENT DISCHARGE

LOCATION OF LOT **Little Creek Road, Lot 27, Block D**

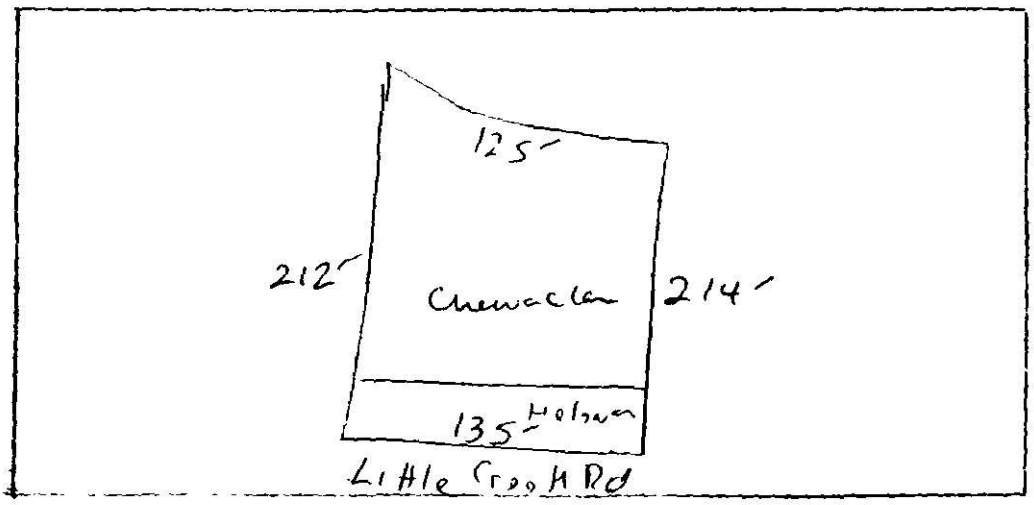
DIAGRAM OF PROPERTY

Soil Properties	Soil 1	Soil 2	Soil 3	Soil 4
1. Soil Series	Holong		Chewacla	
2. Soil Slope	suitable 2-6%		—	
3. Soil Depth	unsuitable <48=		—	
4. Soil Texture	unsuitable 2.1 clays		—	
5. Soil Structure	unsuitable massive		—	
6. Restrictive Horizons	—		—	
7. Soil Drainage	unsuitable perched high water table		unsuitable poorly drained	
8. Soil Permeability (Percolation Rate)	unsuitable very slow >120 min/in.		unsuitable seasonal high water table < 18= from surface	
9. Other	—		unsuitable floods	
10. Overall Rating	unsuitable		unsuitable

Recommendations Based on this investigation, the lot was found to have soils dominantly unsuitable for installation of a septic tank system.
