APPLICATION FOR PERCOLATION TEST

SUBJECT: APT #7015 (J. F. Hodges)
Lot No. 24-B, Middle Stream Road
Rolling Acres Subdivision
10-18-73

SOIL INVESTIGATION REPORT

SITE INVESTIGATION REPORT
INDIVIDUAL SEPTIC TANK SYSTEM
WITH SUBSURFACE,
SOIL ABSORPTION,
EFFLUENT DISCHARGE

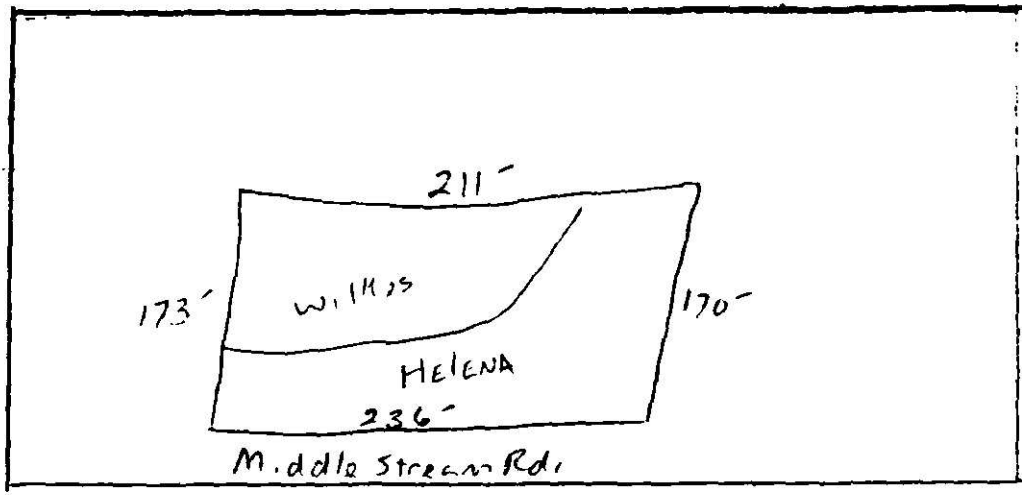
DIAGRAM OF PROPERTY

Soil Properties	Soil 1	Soil 2	Soil 3	Soil 4
1. Soil Series	HELENA		W. Ikes	
2. Soil Slope	suitable 2-6%		suitable 2-6%	
3. Soil Depth	unsuitable <40"		unsuitable <20"	
4. Soil Texture	unsuitable 2:1 expanding clay		unsuitable 2:1 expanding clay	
5. Soil Structure	unsuitable massive		unsuitable massive	
6. Restrictive Horizons	—		—	
7. Soil Drainage	unsuitable perched w/ high water table		unsuitable water table >6"	
8. Soil Permeability (Percolation Rate)	unsuitable very slow >120 min/in		unsuitable very slow >120 min/in	
9. Other	—		—	
10. Overall Rating	unsuitable		unsuitable

Soil drainage unsuitable

Percolation rate in excess of 200 min./in.

Recommendations Based on this investigation, the lot is not recommended for approval for installation of a septic tank system.
