APPLICATION FOR PERCOLATION TEST

APPENDIX H
SITE EVALUATION

SITE INVESTIGATION REPORT
INDIVIDUAL SEPTIC TANK SYSTEM
WITH SUBSURFACE,
SOIL ABSORPTION,
EFFLUENT DISCHARGE

LOCATION OF LOT **Timber Ridge Drive, Lot 21, Block J**

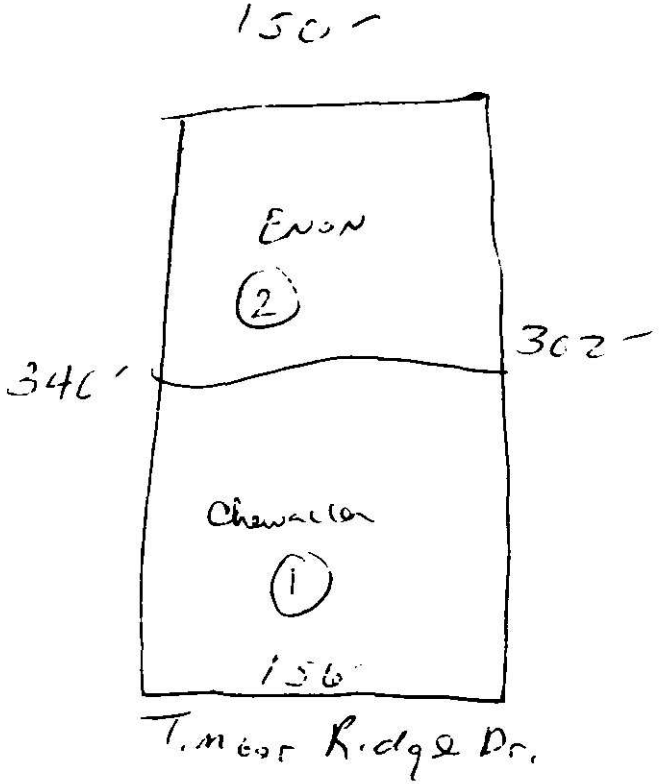
FACTORS	AREA 1	AREA 2	AREA 3	
1. SLOPE (%)	S PS U ——	S PS U 3 E	S PS U	S PS U
2. SOIL TEXTURE (12-36 in.) (Sandy, loamy, clayey, organic clay)	S PS U ——	S PS U Appears to be	S PS U	S PS U
3. SOIL STRUCTURE (12-36 in.) (Blocky soils)	S PS U ——	S PS U Clays	S PS U	S PS U
4. DEPTH (In.)	S PS U ——	S PS U >48"	S PS U	S PS U
5. RESTRICTIVE HORIZONS (In.) (Bedrock, strata, rock)	S PS U ——	S PS U ——	S PS U	S PS U
6. SEASONAL GROUNDWATER (Surface & Internal)	S PS U Perch & Channel	S PS U Perched high water table	S PS U	S PS U
7. PERMEABILITY (Perc Rate)	S PS U Slow to moderate	S PS U very slow >200 min/in	S PS U	S PS U
8. OTHER (Specify)	S PS U flood	S PS U ——	S PS U	S PS U
9. EVALUATION*	wet soil	water table		
10. USE	Chance	Error

Additional Comments: Based on this investigation the lot would have soils demonstrating high water table for installation of a septic tank system.

Soil Structure Massive.

Soil Permeability Unsuitable.
