MECKLENBURG COUNTY
DEPARTMENT OF ENVIRONMENTAL HEALTH

APPLICATION FOR SOIL INVESTIGATION

SITE EVALUATION

(Ground Absorption Sewage Disposal)

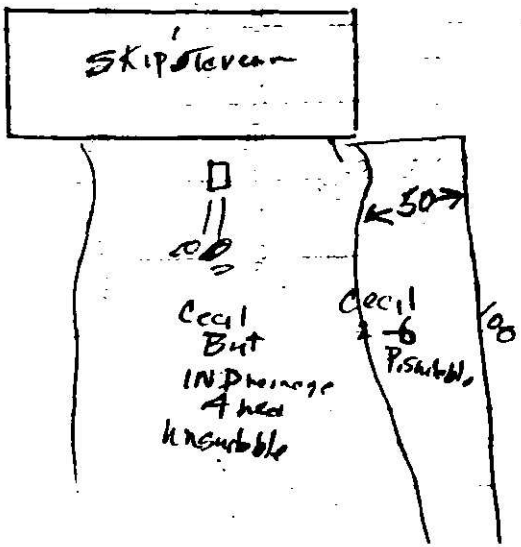
Recommendations/Comments: Soil Has been Abused By Parking Junk Cars on it - But Still is acceptable

Wants To Install New
Tank & Line
