MECKLENBURG COUNTY HEALTH DEPARTMENT

APPLICATION FOR PERCOLATION TEST

SUBJECT: APT: #6961 (John Woodruff)
Windwood Circle, Lot No. 35
7/25/73

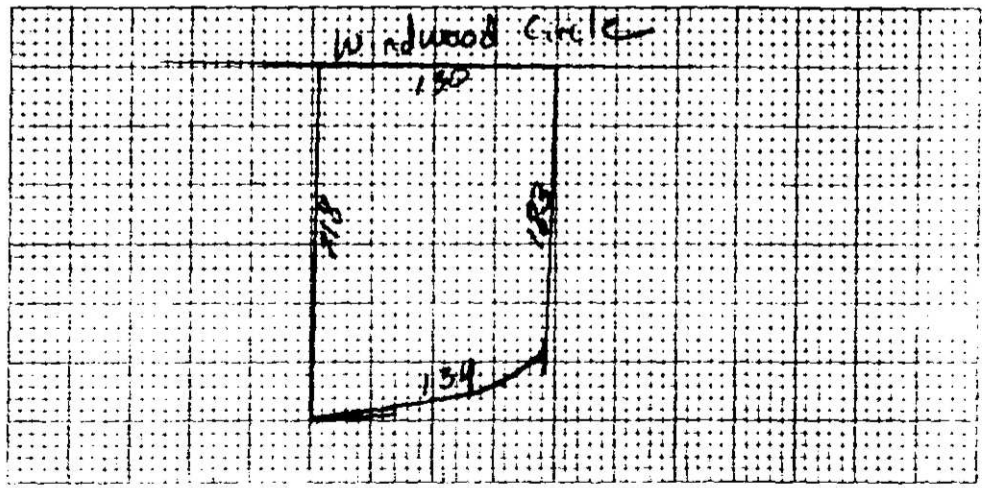
7) ACCURATELY DIAGRAM & DIMENSION LOT

Soils were found to be of the Iredell and Wilkes series. These soils have very plastic and sticky clay subsoils which contain swelling clay minerals. The Iredell soils have a perched high water table during periods of high rainfall. The Wilkes soils are shallow to impervious weathered rock material. These factors result in inadequately slow percolation rate and permeability.

Based on these observations, it is recommended that the lot be disapproved for installation of a septic tank system.
