MECKLENBURG COUNTY
DEPARTMENT OF ENVIRONMENTAL HEALTH

APPLICATION FOR SOIL INVESTIGATION

SOIL INVESTIGATION REPORT

Location of Property Miranda Rd

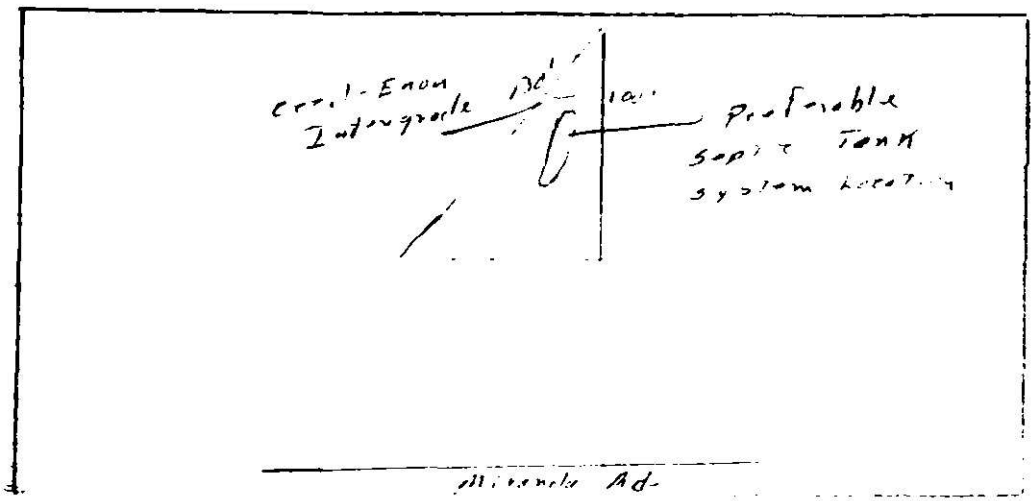
DIAGRAM OF PROPERTY

Recommendations (Generally Favorable) Based on this investigation a limited area is available for the installation of septic tank and leach lines. The leach lines should be placed in the more permeable soils of the area.
