MECKLENBURG COUNTY HEALTH DEPARTMENT

APPLICATION FOR PERCOLATION TEST

SUBJECT: APT # 6962 (John Woodruff)
Windwood Circle, Lot No. 38
7/25/73

APPENDIX H
SITE EVALUATION

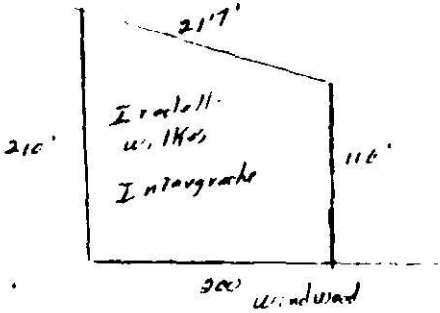
FACTORS	AREA 1	AREA 2	AREA 3	AREA 4
1. SLOPE (%)	(S) PS U — 4-15%	S PS U	S PS U	S PS U +
2. SOIL TEXTURE (12-36 in.) (Sandy, loamy, clayey, Note 2:1, Clay)	S 2:1 PS Expanding (U) Clay	S PS U	S PS U	S PS U
3. SOIL STRUCTURE (12.36 in.) (Clayey Soils)	S Massive PS (U)	S PS U	S PS U	S PS U
4. SOIL DEPTH (In.)	S Variable PS 18" 36" (U)	S PS U	S PS U	S PS U
5. RESTRICTIVE HORIZONS (In.) (Imprevious Strata, Rock)	S Saprolite PS @ 18 36" (U)	S PS U	S PS U	S PS U
6. SOIL DRAINAGE/GROUNDWATER (External & Internal)	(S) ground PS water U 7'+0"	S PS U	S PS U	S PS U
7. SOIL PERMEABILITY (Percolation Rate)	S V Slow PS (U)	S PS U	S PS U	S PS U
8. OTHER (Specify)	S PS U	S PS U	S PS U	S PS U
9. SITE CLASSIFICATION	unsuitable			
SOIL SERIES	Leaf Rolf W. Hks

Recommendations/Comments: Soil unsuitable as requested
John D. Woodruff
