APPLICATION FOR SOIL INVESTIGATION

APPENDIX II
SITE EVALUATION

SITE INVESTIGATION REPORT
INDIVIDUAL SEPTIC TANK SYSTEM
WITH SUBSURFACE,
SOIL ABSORPTION,
EFFLUENT DISCHARGE

LOCATION OF LOT 1700 MARLWOOD CIRCLE, Marlwood Acres, Lot 12, Blk. A

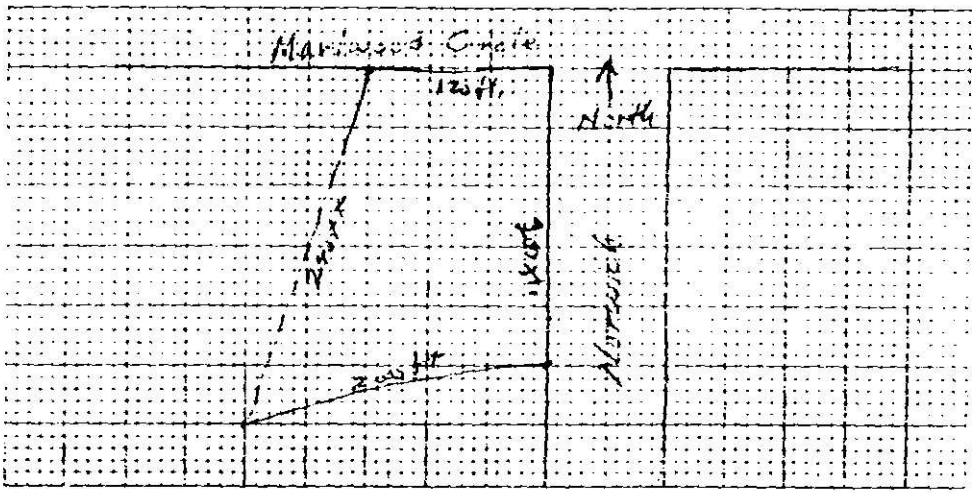
7) ACCURATELY DIAGRAM & DIMENSION LOT
We don't have the exact dimensions, but this is as close as I know.

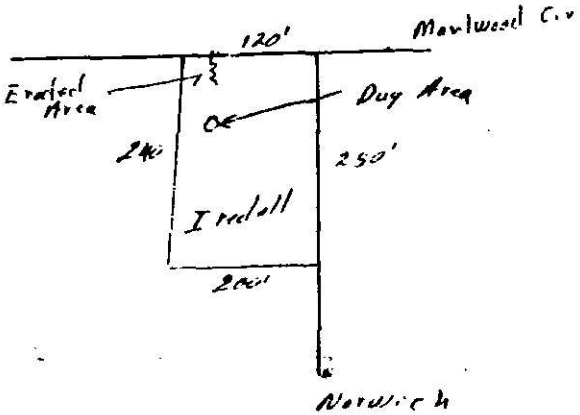
* See Diagram on Back (Include: Soil areas, property lines, roads, streams, gullies, wet areas, fill areas, wells, water bodies, slope patterns, etc)

120'
Mawlwood Cir
Graded Area
Dug Area
24'
250'
Irdell
200'
Norwich
