MECKLENBURG COUNTY HEALTH DEPARTMENT

APPLICATION FOR PERCOLATION TEST

SOIL INVESTIGATION REPORT

Location of Property Providence Ridge Lot No. 6 Block B

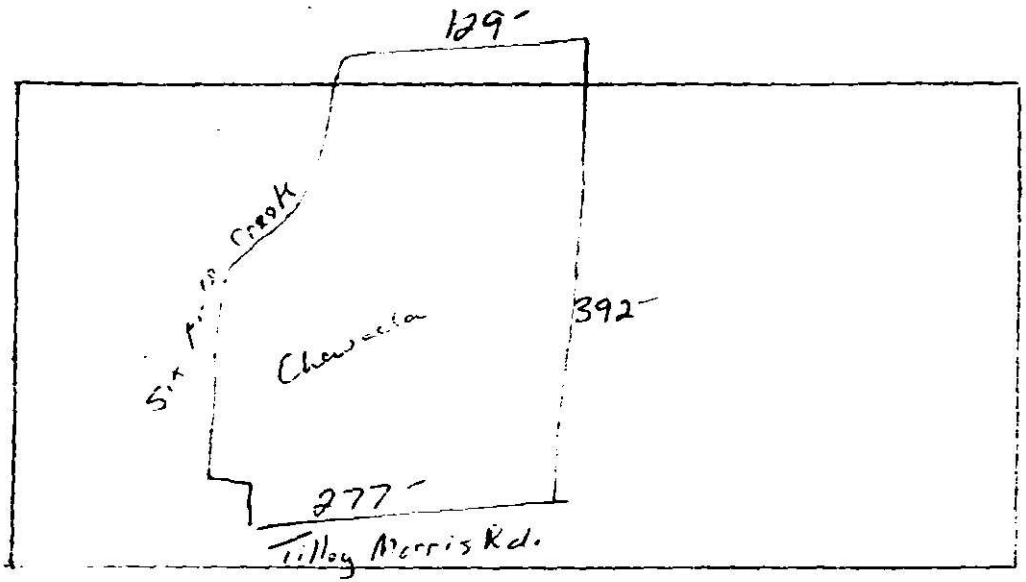
DIAGRAM OF PROPERTY

Soil Properties	Soil 1	Soil 2	Soil 3	Soil 4
1. Soil Series	Chewacla			
2. Soil Slope	—			
3. Soil Depth	—			
4. Soil Texture	—			
5. Soil Structure				
6. Restrictive Horizons				
7. Soil Drainage	unsuitable poorly drained			
8. Soil Permeability (Percolation Rate)	unsuitable seasonal high water table < 18" from surface			
9. Other	unsuitable floods			
10. Overall Rating	unsuitable

Recommendations Based on this investigation, the lot was found not to have an acceptable area of acceptable soils for installation of a septic tank system.
