SITE DISAPPROVAL REPORT
INDIVIDUAL SEPTIC TANK SYSTEM WITH SUBSURFACE,
SOIL ABSORPTION, EFFLUENT DISCHARGE

LOCATION OF LOT Marita Drive, Lot 6-D

SOIL INVESTIGATION REPORT

SITE INVESTIGATION REPORT
INDIVIDUAL SEPTIC TANK SYSTEM
WITH SUBSURFACE,
SOIL ABSORPTION,
EFFLUENT DISCHARGE

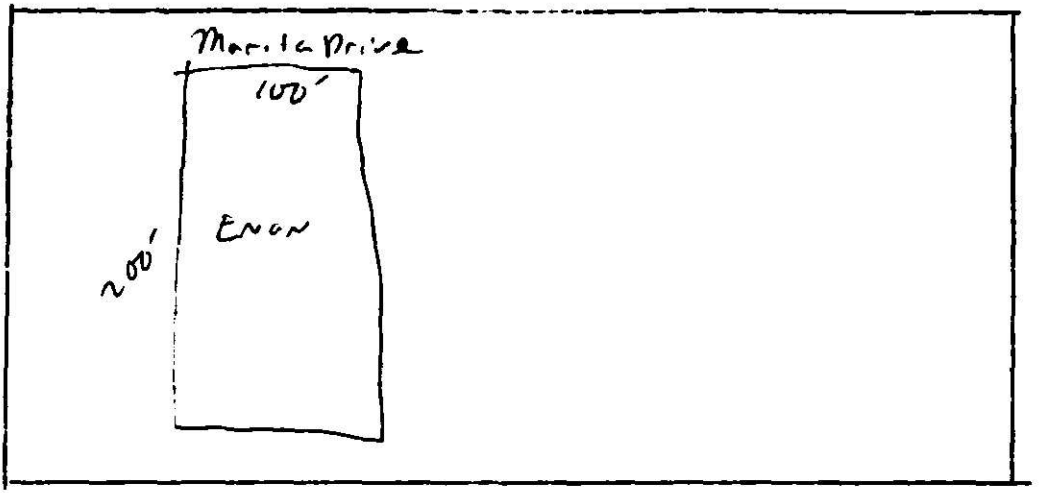
DIAGRAM OF PROPERTY

Soil Properties	Soil 1	Soil 2	Soil 3	Soil 4
1. Soil Series	INON			
2. Soil Slope	acceptable 2-6%			
3. Soil Depth	acceptable 48"			
4. Soil Texture	unacceptable 2:1 EXPANDING clay			
5. Soil Structure	unacceptable massive			
6. Restrictive Horizons	—			
7. Soil Drainage	unacceptable perched high water table			
8. Soil Permeability (Percolation Rate)	unacceptable >200 min/in			
9. Other	—			
10. Overall Rating	unacceptable

Recommendations Based on this investigation, the lot is not recommended for approval for installation of a septic tank system.
