APPLICATION FOR PERCOLATION TEST

APPENDIX II
SITE EVALUATION

SITE INVESTIGATION REPORT
INDIVIDUAL SEPTIC TANK SYSTEM
WITH SUBSURFACE,
SOIL ABSORPTION,
EFFLUENT DISCHARGE

LOCATION OF LOT Dancy Drive, Lots 8 and 9

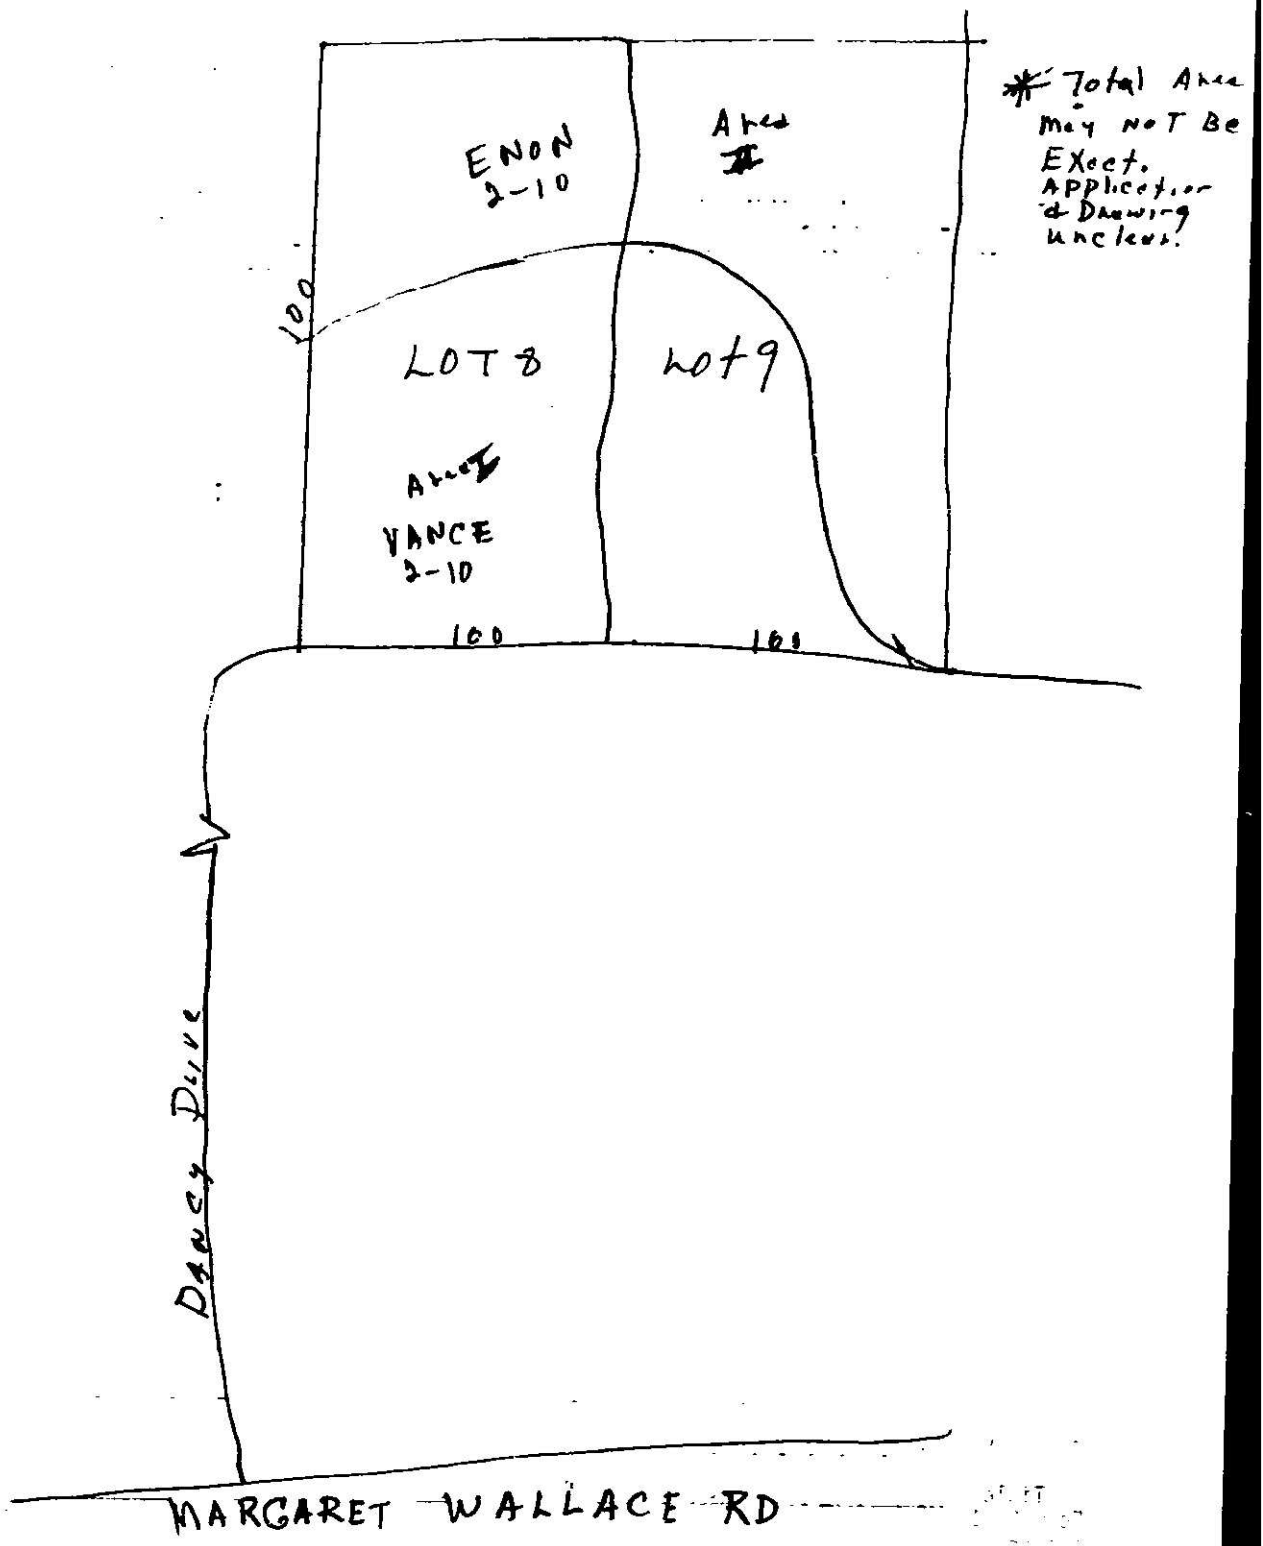
FACTORS	AREA 1	AREA 2	AREA 3	AREA 4
1. SLOPE (%)	(PS) 2–10	(PS) 2–10	S PS U	S PS U
2. SOIL TEXTURE (12-36 in.) (Sandy, loamy, clayey, Note 2:1 Clay)	PS (U) Clayey 2-1	PS (U) Clayey 2-1	S PS U	S PS U
3. SOIL STRUCTURE (12-36 in.) (Clayey Soils)	PS (U) Massive	PS (U) Massive	S PS U	S PS U
4. SOIL DEPTH (In.)	PS (U) <48	PS (U) <48	S PS U	S PS U
5. RESTRICTIVE HORIZONS (In.) (Impervious Strata, Rock)	PS (U) Clays	PS (U) Clays	S PS U	S PS U
6. SOIL DRAINAGE/GROUNDWATER (External & Internal)	PS (U) Slow	PS (U) Very Slow	S PS U	S PS U
7. SOIL PERMEABILITY (Percolation Rate)	PS (U) Slow	PS (U) Slow	S PS U	S PS U
8. OTHER (Specify)	Unsuitable		S PS U	S PS U
9. SITE CLASSIFICATION	Unsuitable	Unsuitable		
SOIL SERIES	VANCE	ENON

ENON
2-10
Area
* Total Area May NOT Be Exact. Application & Drawing Unclear.
100
LOT 8
Lot 9
Area
VANCE
2-10
100
100
DARCY DRIVE
MARGARET WALLACE RD

Soil Structure Massive

Soil Permeability Unsuitable
