MECKLENBURG COUNTY HEALTH DEPARTMENT

APPLICATION FOR PERCOLATION TEST

SOIL INVESTIGATION REPORT

SITE INVESTIGATION REPORT
INDIVIDUAL SEPTIC TANK SYSTEM
WITH SUBSURFACE,
SOIL ABSORPTION,
EFFLUENT DISCHARGE

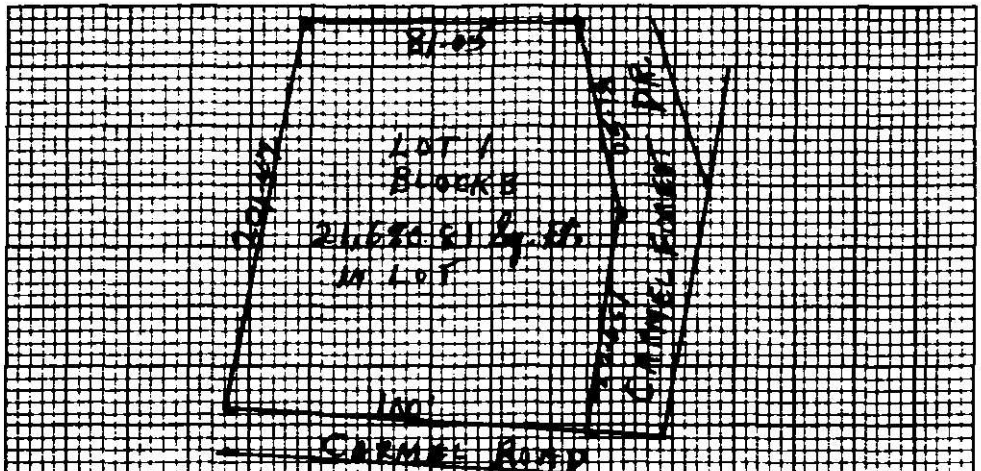
Water available for these 2 lots

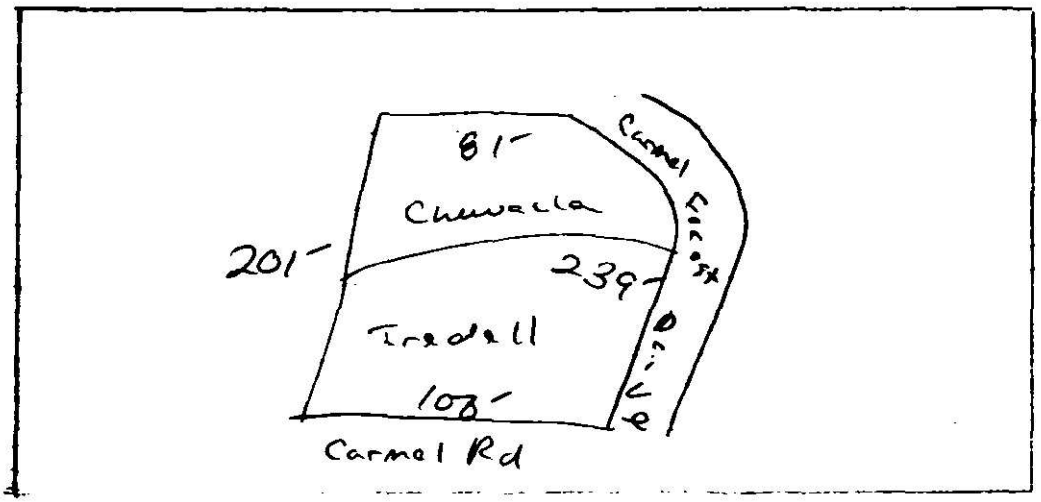
DIAGRAM OF PROPERTY

Soil Properties	Soil 1	Soil 2	Soil 3	Soil 4
1. Soil Series	Iredell		Chewacla	
2. Soil Slope	suitable 3-8%		—	
3. Soil Depth	unsuitable <30"		—	
4. Soil Texture	unsuitable silt loam and clay		—	
5. Soil Structure	unsuitable massive		—	
6. Restrictive Horizons	—		—	
7. Soil Drainage	unsuitable perched high water table		unsuitable poorly drained	
8. Soil Permeability (Percolation Rate)	unsuitable very slow >200 min./in.		unsuitable seasonal high water table <18" from surface	
9. Other			unsuitable floods	
10. Overall Rating	unsuitable		unsuitable

Remarks Recommendations Based on this investigation, the soils were found to be dominantly unsuitable for installation of a septic tank system.
