4030 LOCHFOOT DR

Inspection of Engineered Subsurface Wastewater System

Mecklenburg County	FRANKLIN RESIDENCE	6193B
Health Department	**Name of Establishment**	**Permit/Project No.**
4030 LOCHFOOT DR	RESIDENCE	360
Location	**Type of Establishment**	**Design Flow**
SAMUEL J FRANKLIN III	4030 LOCHFOOT DR	
Owner/Agent	**Address**	**Phone**
	CHARLOTTE NC 28278	
Operator	**Address**	**Phone**
IIIb	2/1/12	2/1/2017
System Type	**Date of Inspection**	**Next Inspection Due**

OPERATION PERMIT for an ON-SITE WASTEWATER TREATMENT & DISPOSAL SYSTEM

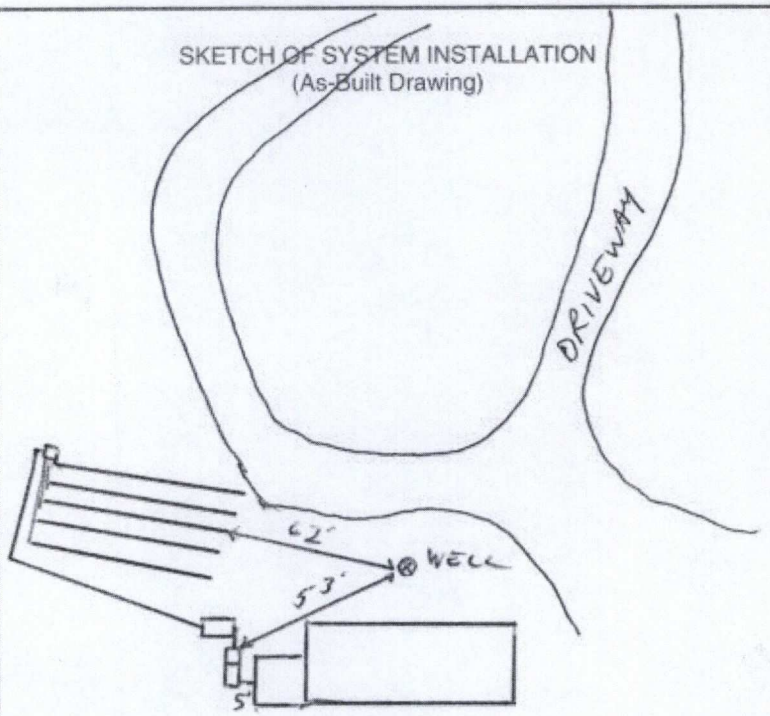
SKETCH OF SYSTEM INSTALLATION
(As-Built Drawing)

Comments: System Classification & Type: IIIb PUMP 25% REDUCTION; QUICK 4 INFILTRATORS
