APPLICATION FOR SOIL INVESTIGATION

SITE EVALUATION

(Ground Absorption Sewage Disposal)

Re: Property located at Rozwood Drive

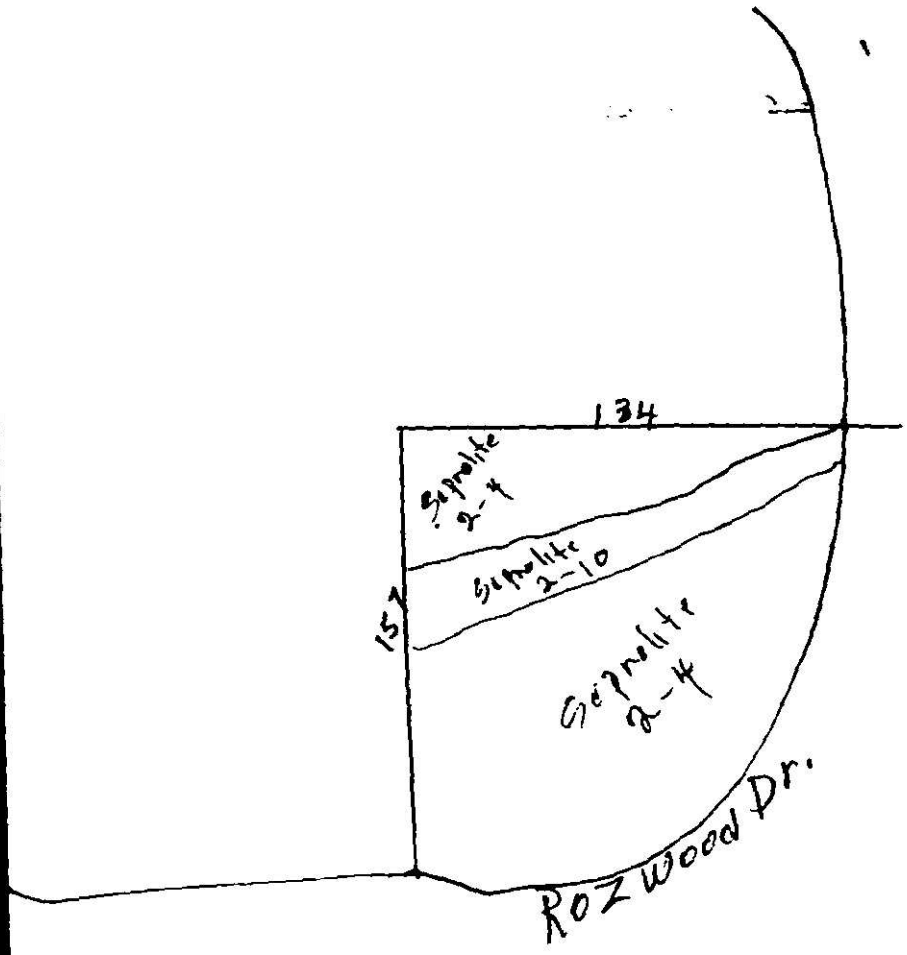
FACTORS	AREA 1	AREA 2	AREA 3	AREA 4
1. SLOPE (%)	S (PS) 2-10 U	S PS U	S PS U	S PS U
2. SOIL TEXTURE (12-36 inches) Sandy, Loamy, Clayey (Note 2-1 Clay)	S Saprolite PS (U)	S PS U	S PS U	S PS U
3. SOIL STRUCTURE (12-36 inches)	S Decayed PS Rock (U)	S PS U	S PS U	S PS U
4. SOIL DEPTH (inches)	S PS 1-2' (U)	S PS U	S PS U	S PS U
5. RESTRICTIVE HORIZONS (Inches) (Impervious strata, Rock)	S (PS) None U	S PS U	S PS U	S PS U
6. SOIL DRAINAGE/GROUNDWATER (external and internal)	S PS Slod (U)	S PS U	S PS U	S PS U
7. OTHER (Specify)	S PS U	S PS U	S PS U	S PS U
8. SOIL GROUP	None			
9. SITE CLASSIFICATION	Unsuitable			
10. SOIL SERIES	Saprolite - A-C. (Not Enough Soil For Wilkes - No Clay

134
Saprolite
2-4
Saprolite
2-10
157
Saprolite
2-4
Rozwood Dr.
