MECKLENBURG COUNTY
DEPARTMENT OF ENVIRONMENTAL HEALTH

SITE EVALUATION

S.I.R. NO. 20459

RE: Property located at Blair Road

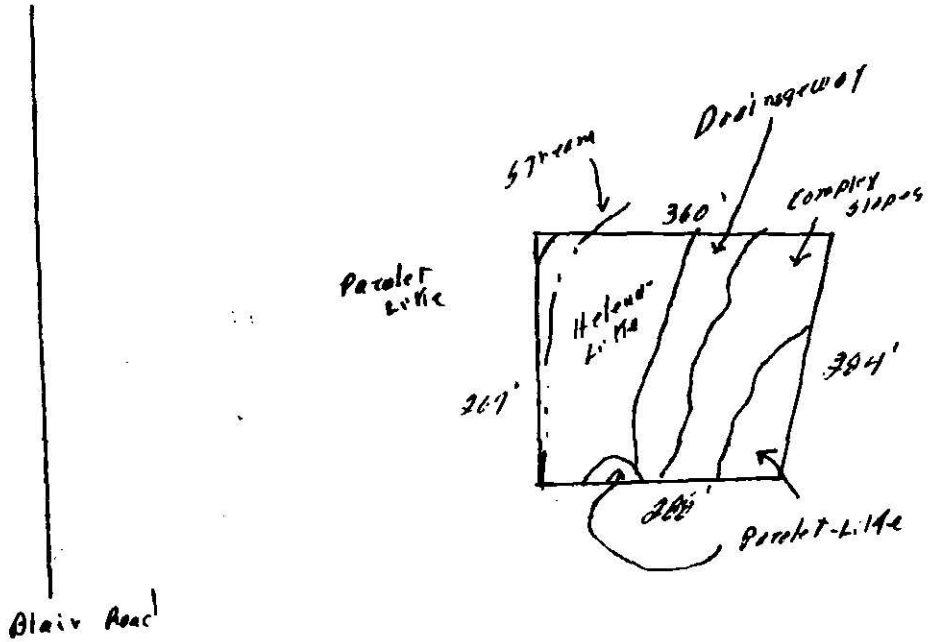
FACTORS	AREA 1	AREA 2	AREA 3	AREA 4
1. SLOPE (%)	S PS U 2-10%	S PS U Complex slopes	S PS U 2-8%	S PS U
2. SOIL TEXTURE (12-36 inches) Sandy, Loamy, Clayey (Note 2-1 Clay)	S PS U clay	S PS U clay	S PS U 2-1 Clay	S PS U
3. SOIL STRUCTURE (12-36 inches)	S PS U Blocky	S PS U Blocky	S PS U Blocky	S PS U
4. SOIL DEPTH (inches)	S PS U 24-30"	S PS U < 30"	S PS U 36-40"	S PS U
5. RESTRICTIVE HORIZONS (Inches) (Impervious strata, Rock)	S PS U < 36"	S PS U < 30"	S PS U > 36"	S PS U
6. SOIL DRAINAGE/GROUNDWATER (external and internal)	S PS U > 36" to ground water	S PS U Eroded Areas channel runoff	S PS U 20-30" to ground water	S PS U
7. OTHER (Specify)	S PS U	S PS U	S PS U	S PS U
8. SOIL GROUP	IVA	IVA	IVB	
9. SITE CLASSIFICATION	unsuitable	unsuitable	unsuitable	
10. SOIL SERIES	Pocalet Like	Complex slopes	Helena Like

Stream
Drainageway
360'
Complex slopes
Parallel Lake
Helena Lake
384'
267'
288'
Parallel-Lake
Blair Road
