MECKLENBURG COUNTY
DEPARTMENT OF ENVIRONMENTAL HEALTH

APPLICATION FOR SOIL INVESTIGATION

APPENDIX II
SITE EVALUATION

SITE INVESTIGATION REPORT
INDIVIDUAL SEPTIC TANK SYSTEM
WITH SUBSURFACE,
SOIL ABSORPTION,
EFFLUENT DISCHARGE

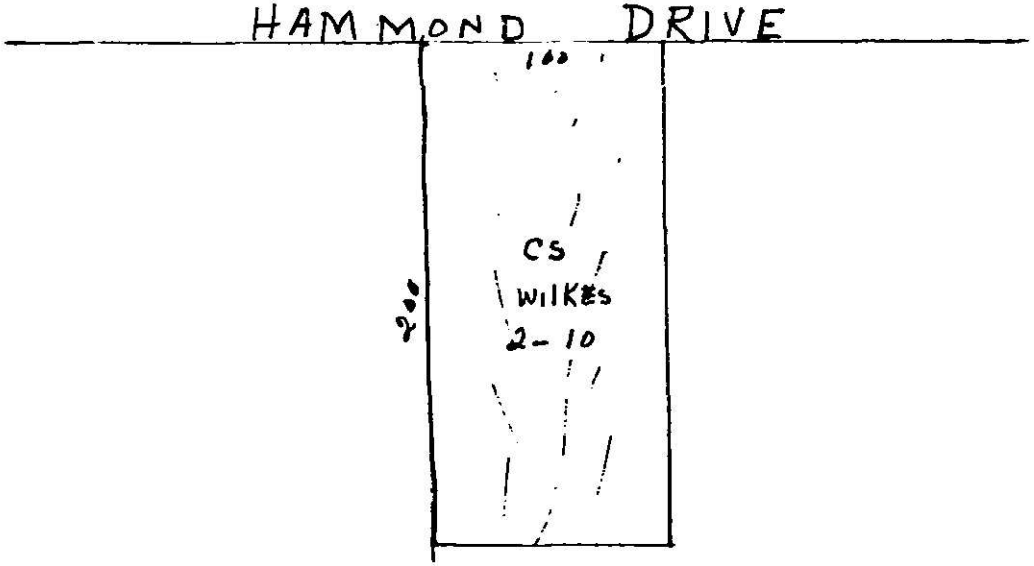
LOT 35

FACTORS	AREA 1	AREA 2	AREA 3	AREA 4
1. SLOPE (%)	S PS (U) Complex	S PS U	S PS U	S PS U
2. SOIL TEXTURE (12-36 in.) (Sandy, loamy, clayey, Note 2:1 Clay)	S PS (U) Clayey To Saprolite	S PS U	S PS U	S PS U
3. SOIL STRUCTURE (12.36 in.) (Clayey Soils)	S ~~PS~~ (U) MASSIVE	S PS U	S PS U	S PS U
4. SOIL DEPTH (In.)	S PS (U) <48	S PS U	S PS U	S PS U
5. RESTRICTIVE HORIZONS (In.) (Impervious Strata, Rock)	S PS (U) Saprolite	S PS U	S PS U	S PS U
6. SOIL DRAINAGE/GROUNDWATER (External & internal)	S PS (U) Slow	S PS U	S PS U	S PS U
7. SOIL PERMEABILITY (Percolation Rate)	S ~~PS~~ (U) Slow	S PS U	S PS U	S PS U
8. OTHER (Specify)	S PS U	S PS U	S PS U	S PS U
9. SITE CLASSIFICATION	Unsuitable			
SOIL SERIES	Wilkes Complex Slopes

As determined under the Rules and Regulations promulgated by the Commission for Health Services, Division of Health Services, North Carolina Department of Human Resources, Raleigh, North Carolina, the soils on the lot described above were found to be unsuitable for the installation of an individual septic tank - soil absorption system, due to the following reason:

Soil Structure Massive

Soil Permeability Unsuitable
