MECKLENBURG COUNTY HEALTH DEPARTMENT

APPLICATION FOR PERCOLATION TEST

SOIL INVESTIGATION REPORT

SITE INVESTIGATION REPORT
INDIVIDUAL SEPTIC TANK SYSTEM
WITH SUBSURFACE,
SOIL ABSORPTION,
EFFLUENT DISCHARGE

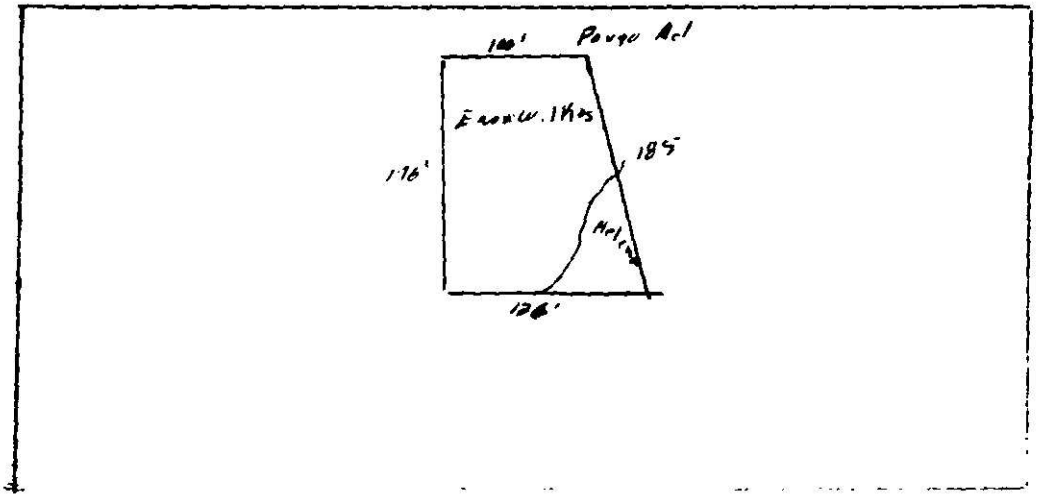
DIAGRAM OF PROPERTY

Soil Properties	Soil 1	Soil 2	Soil 3	Soil 4
1. Soil Series	Exum-Wilkes	Helena		
2. Soil Slope	Suitable 2-6%	Suitable 2-7%		
3. Soil Depth	Unsuitable 40"	Suitable 48"		
4. Soil Texture	unsuitable 2:1 Expanding Clay	unsuitable 2:1 Expanding Clay		
5. Soil Structure	unsuitable Mass [illegible]	unsuitable Mass [illegible]		
6. Restrictive Horizons	-			
7. Soil Drainage	suitable [illegible] water table	unsuitable perched high water Table		
8. Soil Permeability (Percolation Rate)	unsuitable [illegible] slow	unsuitable >200 min/in		
9. Other				
10. Overall Rating	unsuitable	unsuitable

Remarks:
Recommendations Based on this investigation, the soils on the site are considered to be unsuitable for the installation of septic tank systems.

The lot described above is not recommended for the installation of an individual septic tank system with subsurface, soil absorption, effluent discharge due to the following:

Soil Permeability Unsuitable.

Percolation rate in excess of 200 min/in.
