APPLICATION FOR SOIL INVESTIGATION

APPENDIX B
SITE EVALUATION

SITE INVESTIGATION REPORT
INDIVIDUAL SEPTIC TANK SYSTEM
WITH SUBSURFACE,
SOIL ABSORPTION,
EFFLUENT DISCHARGE

S.I.R. # 16265

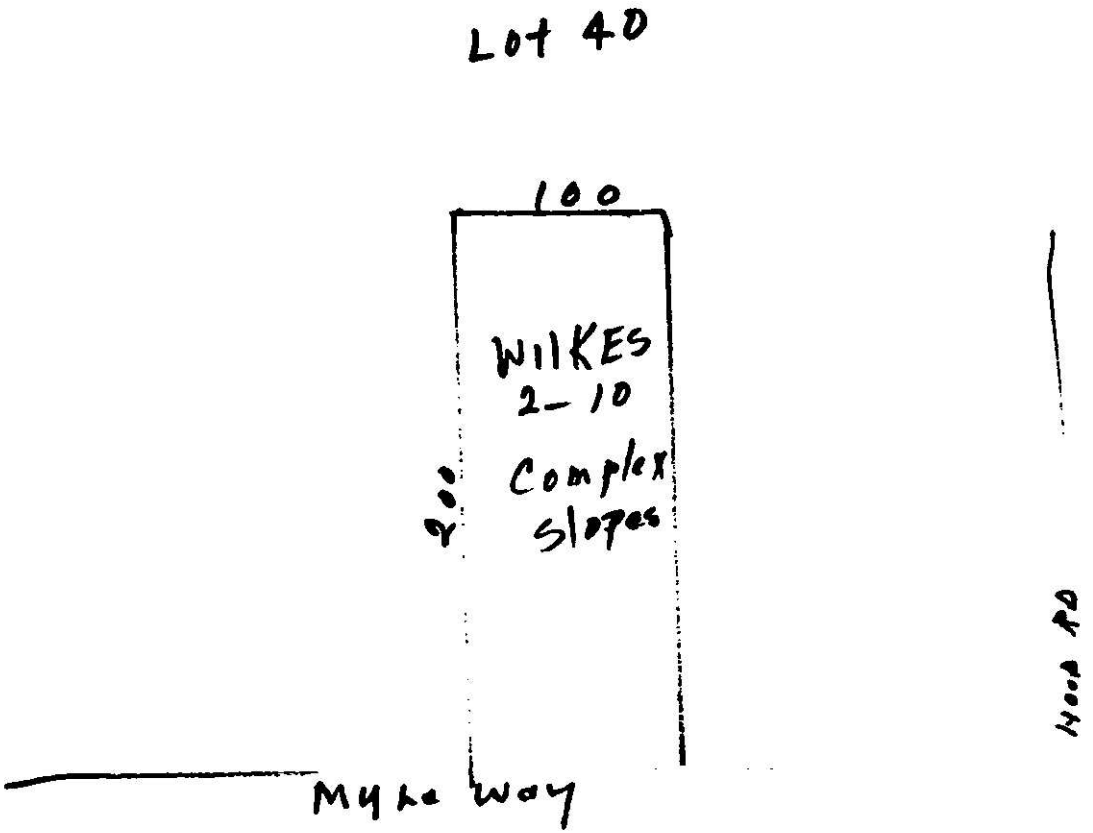
FACTORS		AREA 1	AREA 2	AREA 3	AREA 4
1. SLOPE (%)	S		S	S	S
	PS	2-10	PS	PS	PS
	U		U	U	U
2. SOIL TEXTURE (12-36 in.) (Sandy loamy clayey, Note 2.1 Clay)	S		S	S	S
	PS	2-1 clay	PS	PS	PS
	U	Saprolite	U	U	U
3. SOIL STRUCTURE (12-36 in.) (Clayey Soils)	S		S	S	S
	PS	MASSIVE	PS	PS	PS
	U		U	U	U
4. SOIL DEPTH (In.)	S		S	S	S
	PS	48	PS	PS	PS
	U		U	U	U
5. RESTRICTIVE HORIZONS (In.) (Impervious Strata Rock)	S		S	S	S
	PS	Saprolite	PS	PS	PS
	U		U	U	U
6. SOIL WETNESS/WATER TABLE (External Internal)	S		S	S	S
	PS	SLOW	PS	PS	PS
	U		U	U	U
7. SOIL PERMEABILITY (Percolation Rate)	S		S	S	S
	PS	SLOW	PS	PS	PS
	U		U	U	U
8. OTHER (Specify)	S		S	S	S
	PS		PS	PS	PS
	U		U	U	U
9. SITE CLASSIFICATION		Unsuitable

Lot 40
100
WILKES
2-10
Complex
Slopes
200'
Myra Way
Wood Rd
