## APPLICATION FOR SOIL INVESTIGATION

APPENDIX H
SITE EVALUATION

S. I. R. NO. 16103

SITE INVESTIGATION REPORT
INDIVIDUAL SEPTIC TANK SYSTEM
WITH SUBSURFACE,
SOIL ABSORPTION,
EFFLUENT DISCHARGE

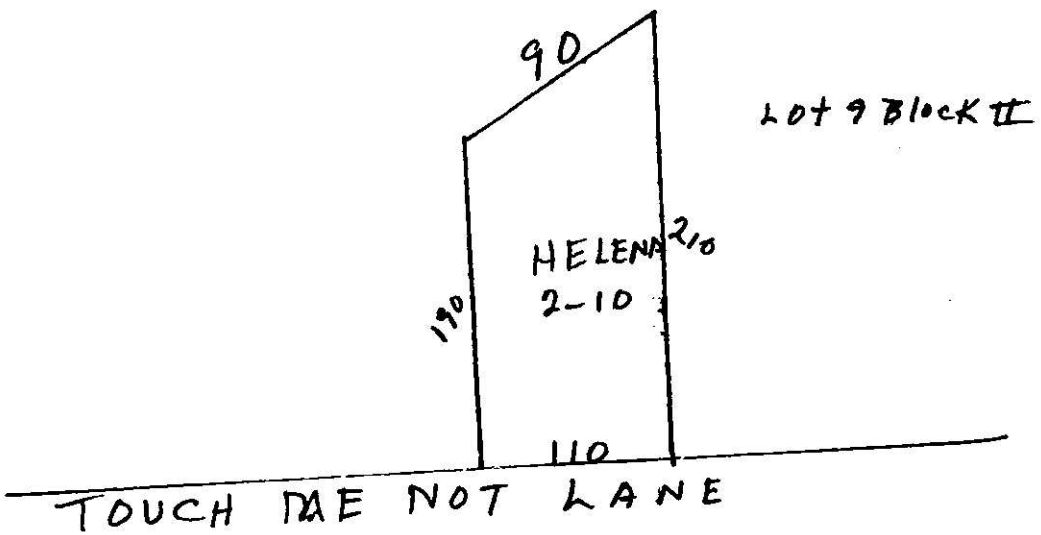
* See Diagram on Back (Include: Soil areas, property lines, roads, streams, gullies, wet areas, fill areas, wells, water bodies, slope patterns, etc.)

Recommendations/Comments: SEVERE DRAINAGE

90
LOT 9 BLOCK II
HELENA
2-10
2/0
190
110
TOUCH ME NOT LANE
