MECKLENBURG COUNTY
DEPARTMENT OF ENVIRONMENTAL HEALTH

APPLICATION FOR SOIL INVESTIGATION

APPENDIX H
SITE EVALUATION

SITE INVESTIGATION REPORT
INDIVIDUAL SEPTIC TANK SYSTEM
WITH SUBSURFACE,
SOIL ABSORPTION,
EFFLUENT DISCHARGE

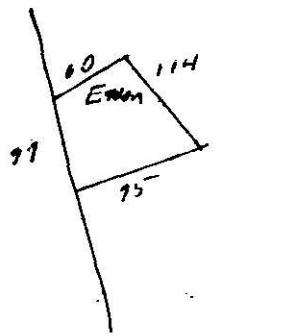
FACTORS	AREA 1	AREA 2	AREA 3	AREA 4
1. SLOPE (%)	(S) PS 2-10% U	S PS U	S PS U	S PS U
2. SOIL TEXTURE (12-36 in.) (Sandy, loamy, clayey, Note 2:1, Clay)	S PS 2-1 (U) clay	S PS U	S PS U	S PS U
3. SOIL STRUCTURE (12.36 in.) (Clayey Soils)	S PS Massive (U)	S PS U	S PS U	S PS U
4. SOIL DEPTH (In.)	S PS ~48" (U)	S PS U	S PS U	S PS U
5. RESTRICTIVE HORIZONS (In.) (Imprevious Strata, Rock)	(S) None PS U	S PS U	S PS U	S PS U
6. SOIL DRAINAGE/GROUNDWATER (External & Internal)	(S) 76" to ground PS water U	S PS U	S PS U	S PS U
7. SOIL PERMEABILITY (Percolation Rate)	S PS unsuitable (U)	S PS U	S PS U	S PS U
8. OTHER (Specify)	S PS U	S PS U	S PS U	S PS U
9. SITE CLASSIFICATION	unsuitable			
SOIL SERIES	Enon

* See Diagram on Back (Include: Soil areas, property lines, roads, streams, gullies, wet areas, fill areas, wells, water bodies, slope patterns, etc)
